Ann Donovan, Watershed Specialist
April 8, 2014

CCCD Manure
Management
workshop

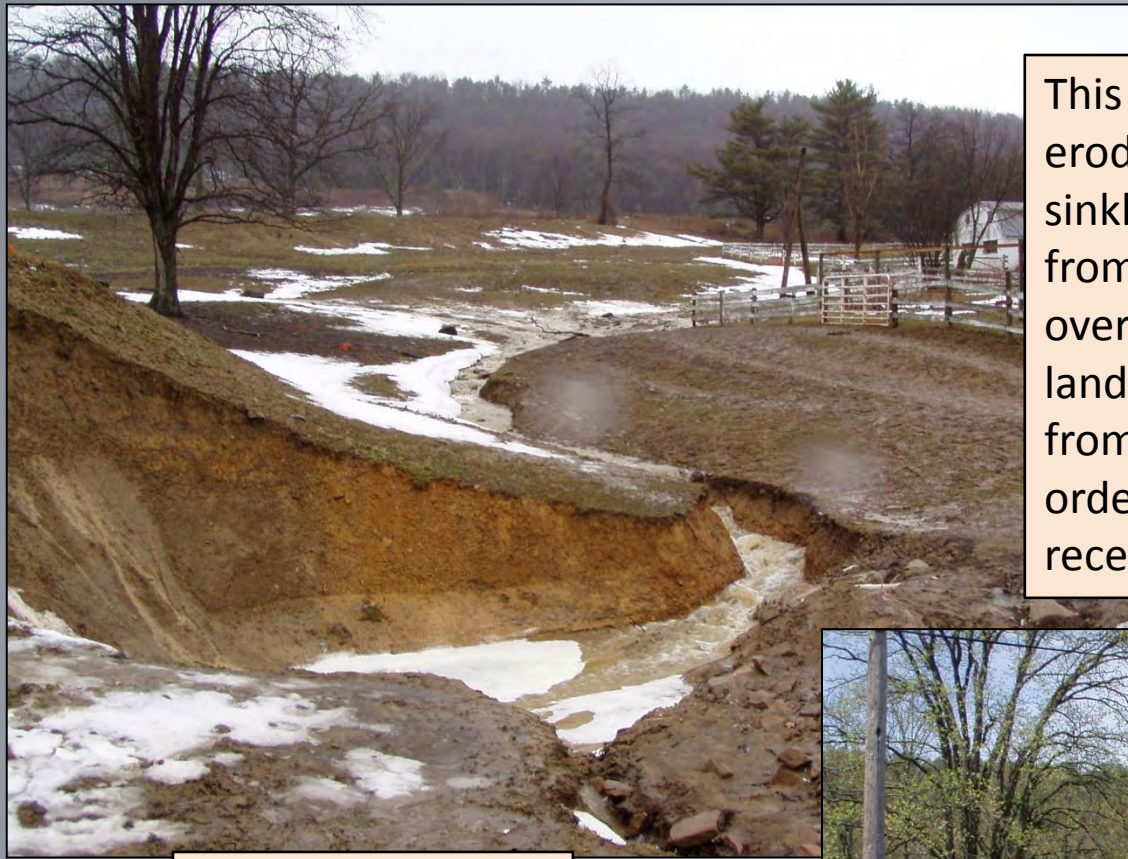
Sam S. Zook Farm

This picture shows runoff from an eroded waterway dumping into a sinkhole. Pile of soil on the left came from the fields above the waterway over the course of several years. The landowner has had the soil removed from the sinkhole several times in order to keep the sinkhole open to receive water.

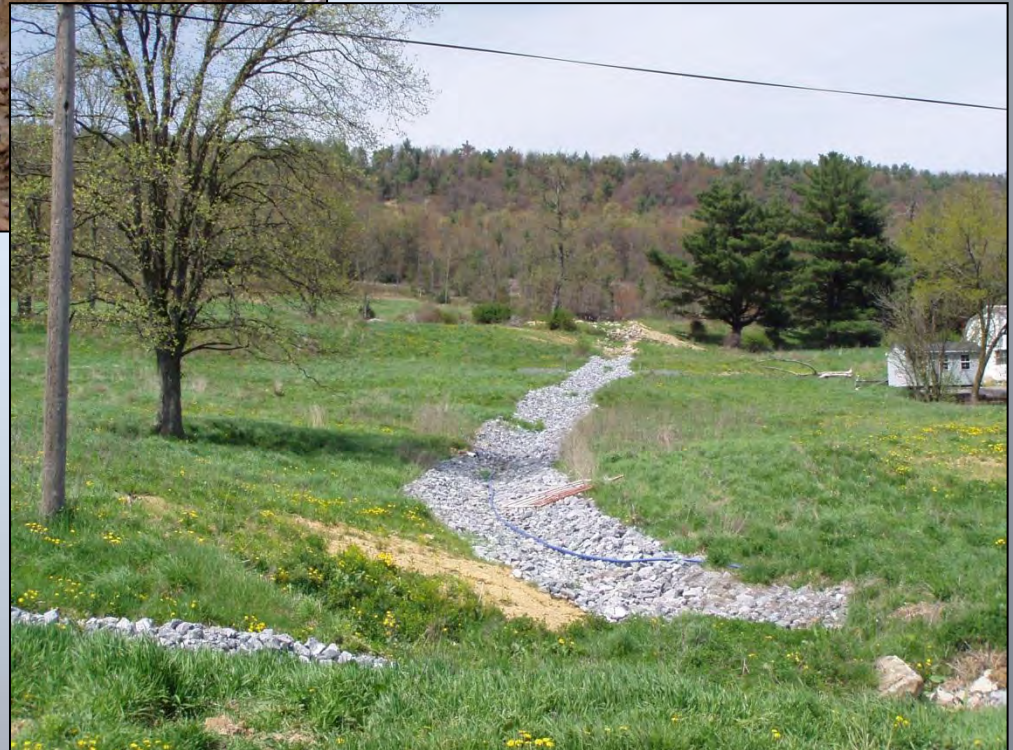
Same picture as above after waterway has been stabilized. Soil pile was spread out and area seeded in grass. This waterway originates at a farm pond and is 531 feet in length. Fields above pond / waterway are now in permanent sod.

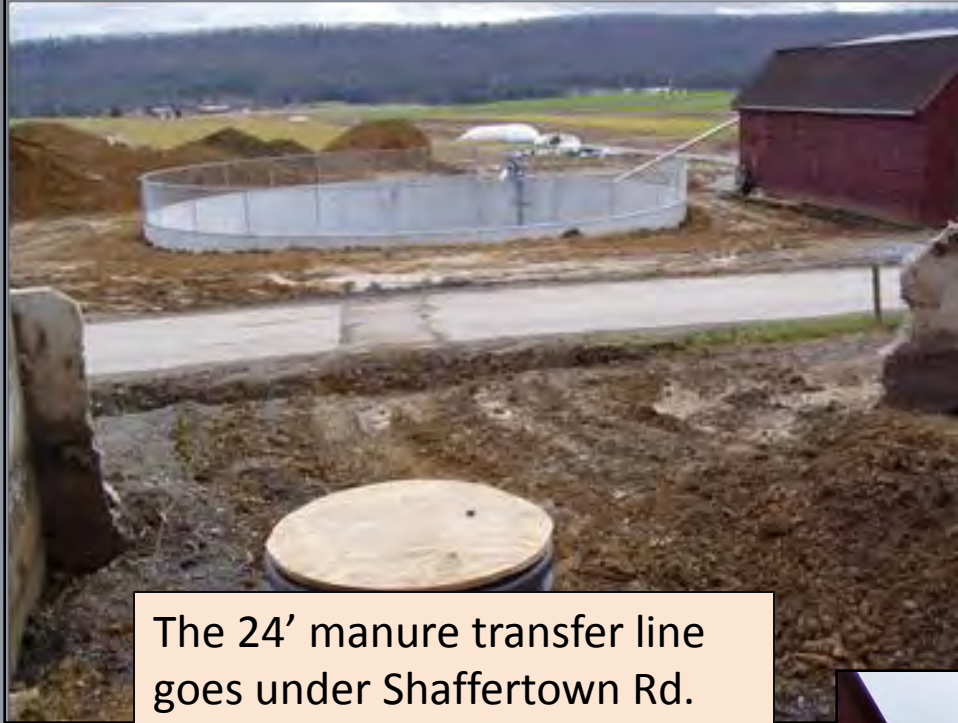
New manure storage (65' x 10') with access lane, Dry Hill stationary pump and pump pad with side walls.

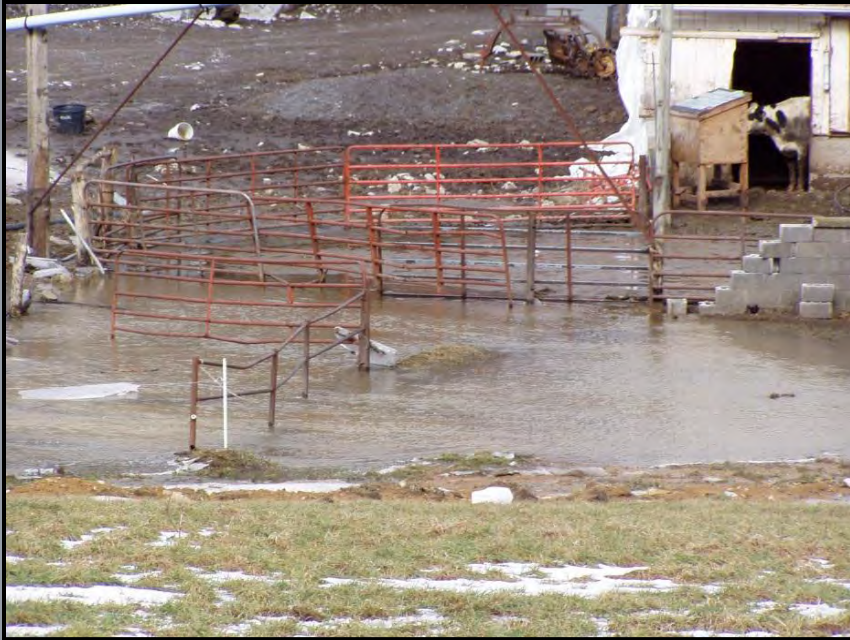
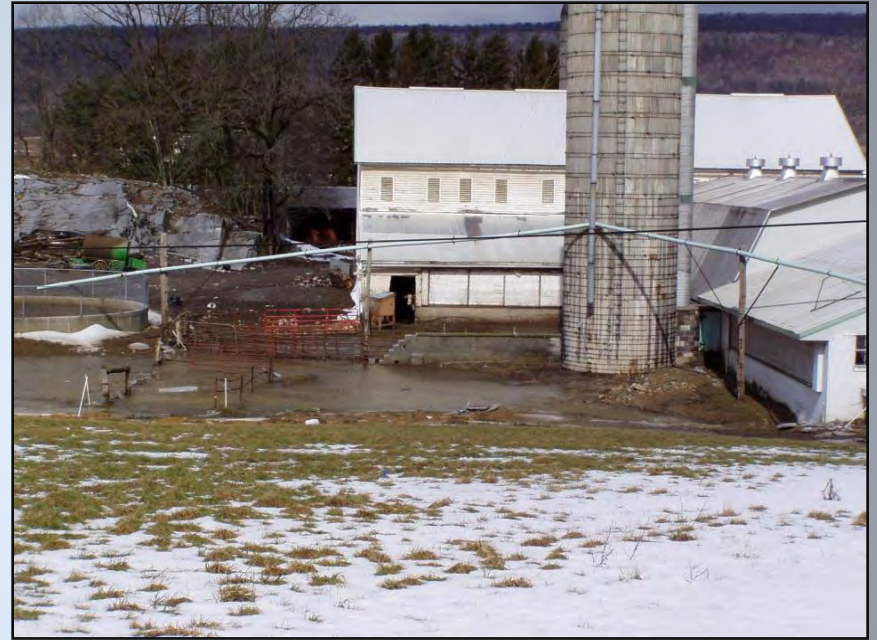
Flooded Heavy Use Area (HUA) during a runoff event contributed by snow melt & rainfall. Runoff from this area directly impacts Spring Bank Run, Elk Creek and the Elk Creek Fish Hatchery.

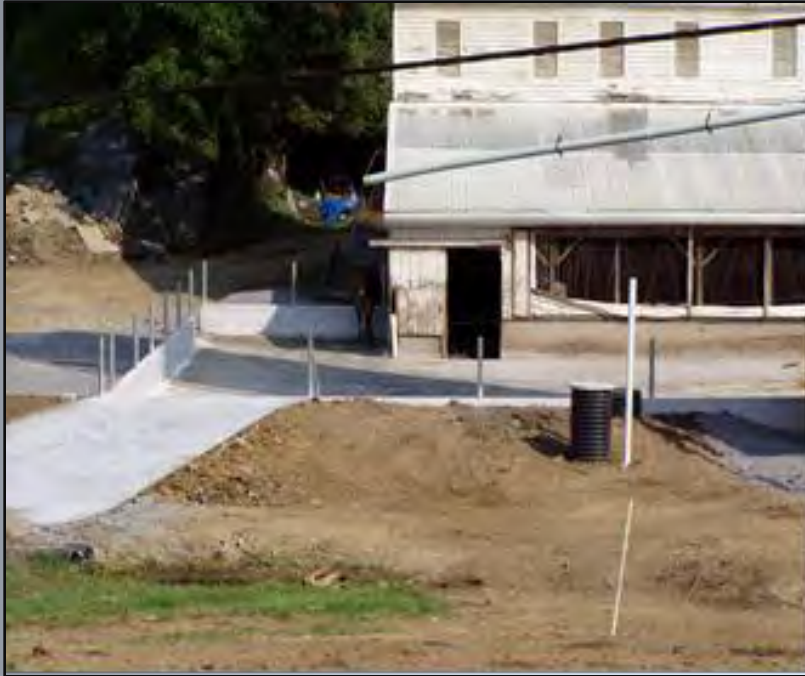
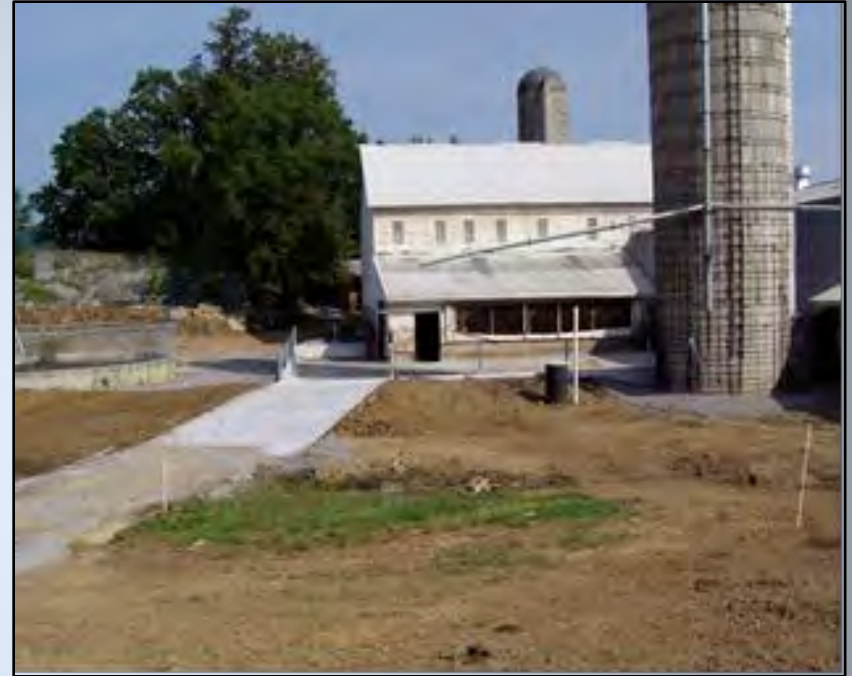
These pictures show construction nearing completion just before area was seeded and the fence completed. The floor of the HUA was raised 6 inches. A 2 foot curb with stairs was placed around the HUA. A 2 foot high earthen berm was placed around the outside of the HUA. The black riser culvert pipe and the white PVC riser pipe are part of the leachate collection system.

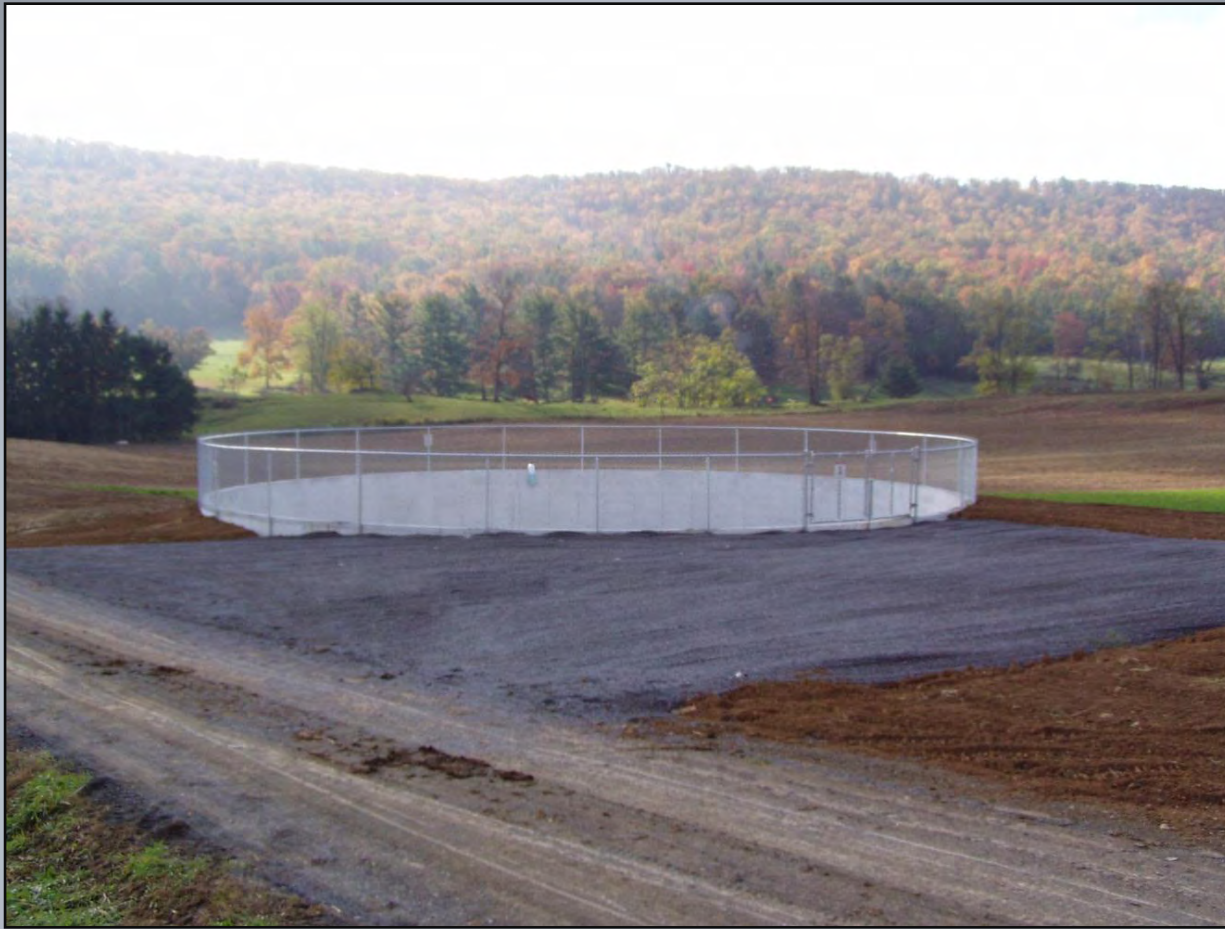
New 60' x 10' Concrete Manure Storage and Heavy Use Area Protection.

The storage is located just off the access road that splits the farm fields.

This enables easy access to all crop fields that receive liquid manure.

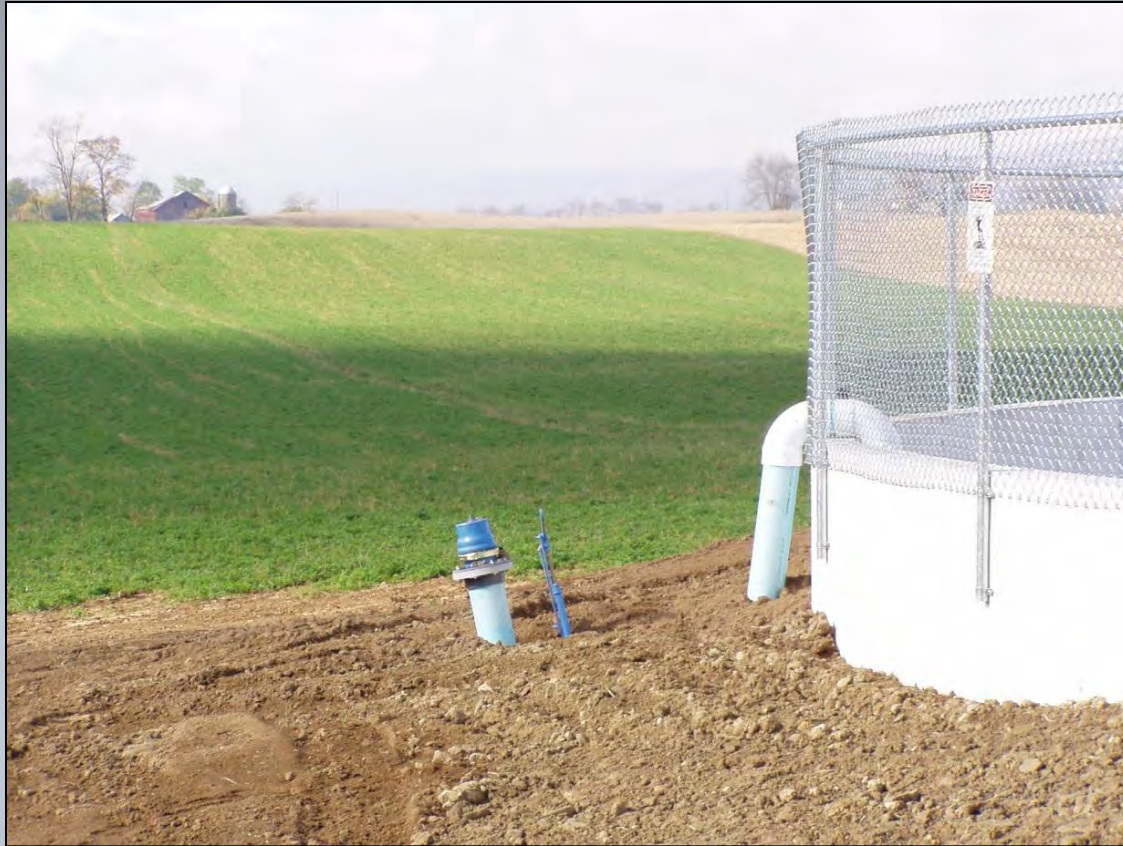
780 feet of 6 inch manure transfer pipeline (hanging over wall) allows manure to be pumped from the existing manure storage, located down by the barn and Heavy Use Area, up to the new storage which is centrally located in the crop fields. We located the storage here because it was easier for the draft horses when they were spreading.

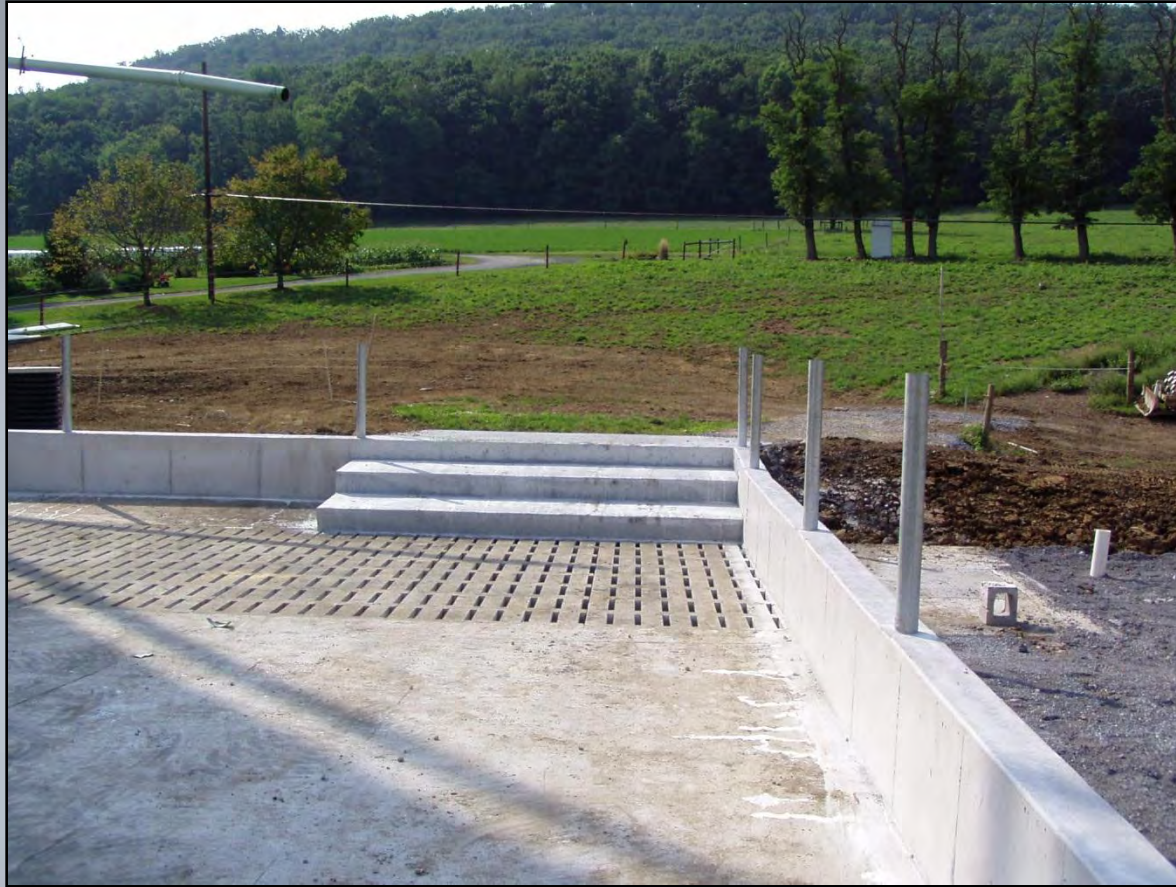
This is a picture from inside the Heavy Use Area Protection prior to fence being completed.

The stairs allow the cows to climb out over the curb and the earthen berm.

Below the slotted floor is the 38' x 11' x 8' reception pit.

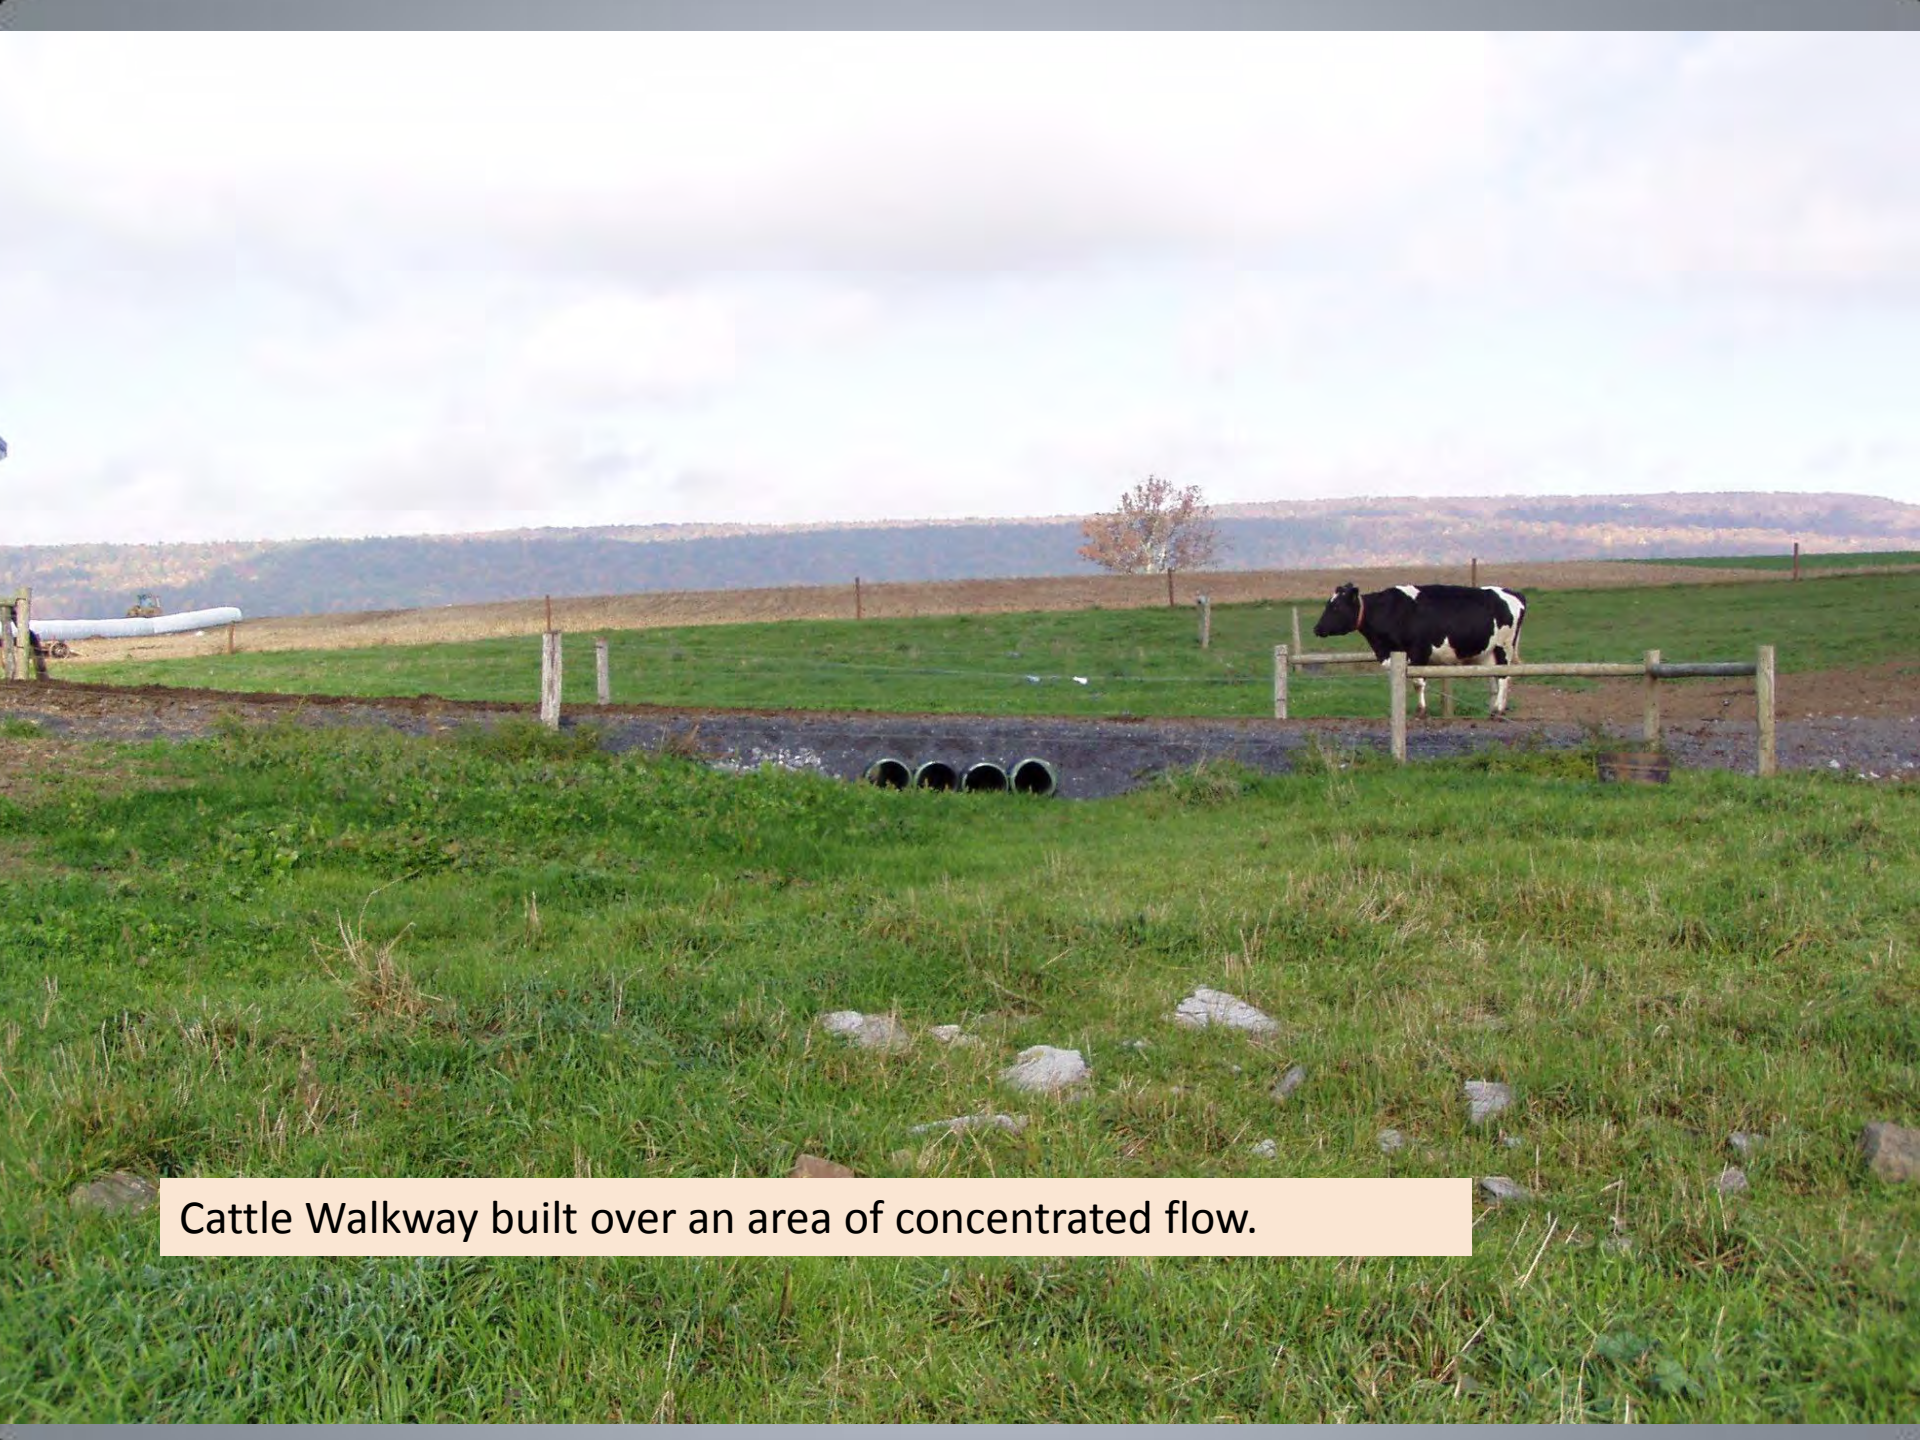
Cattle Walkway built over an area of concentrated flow.

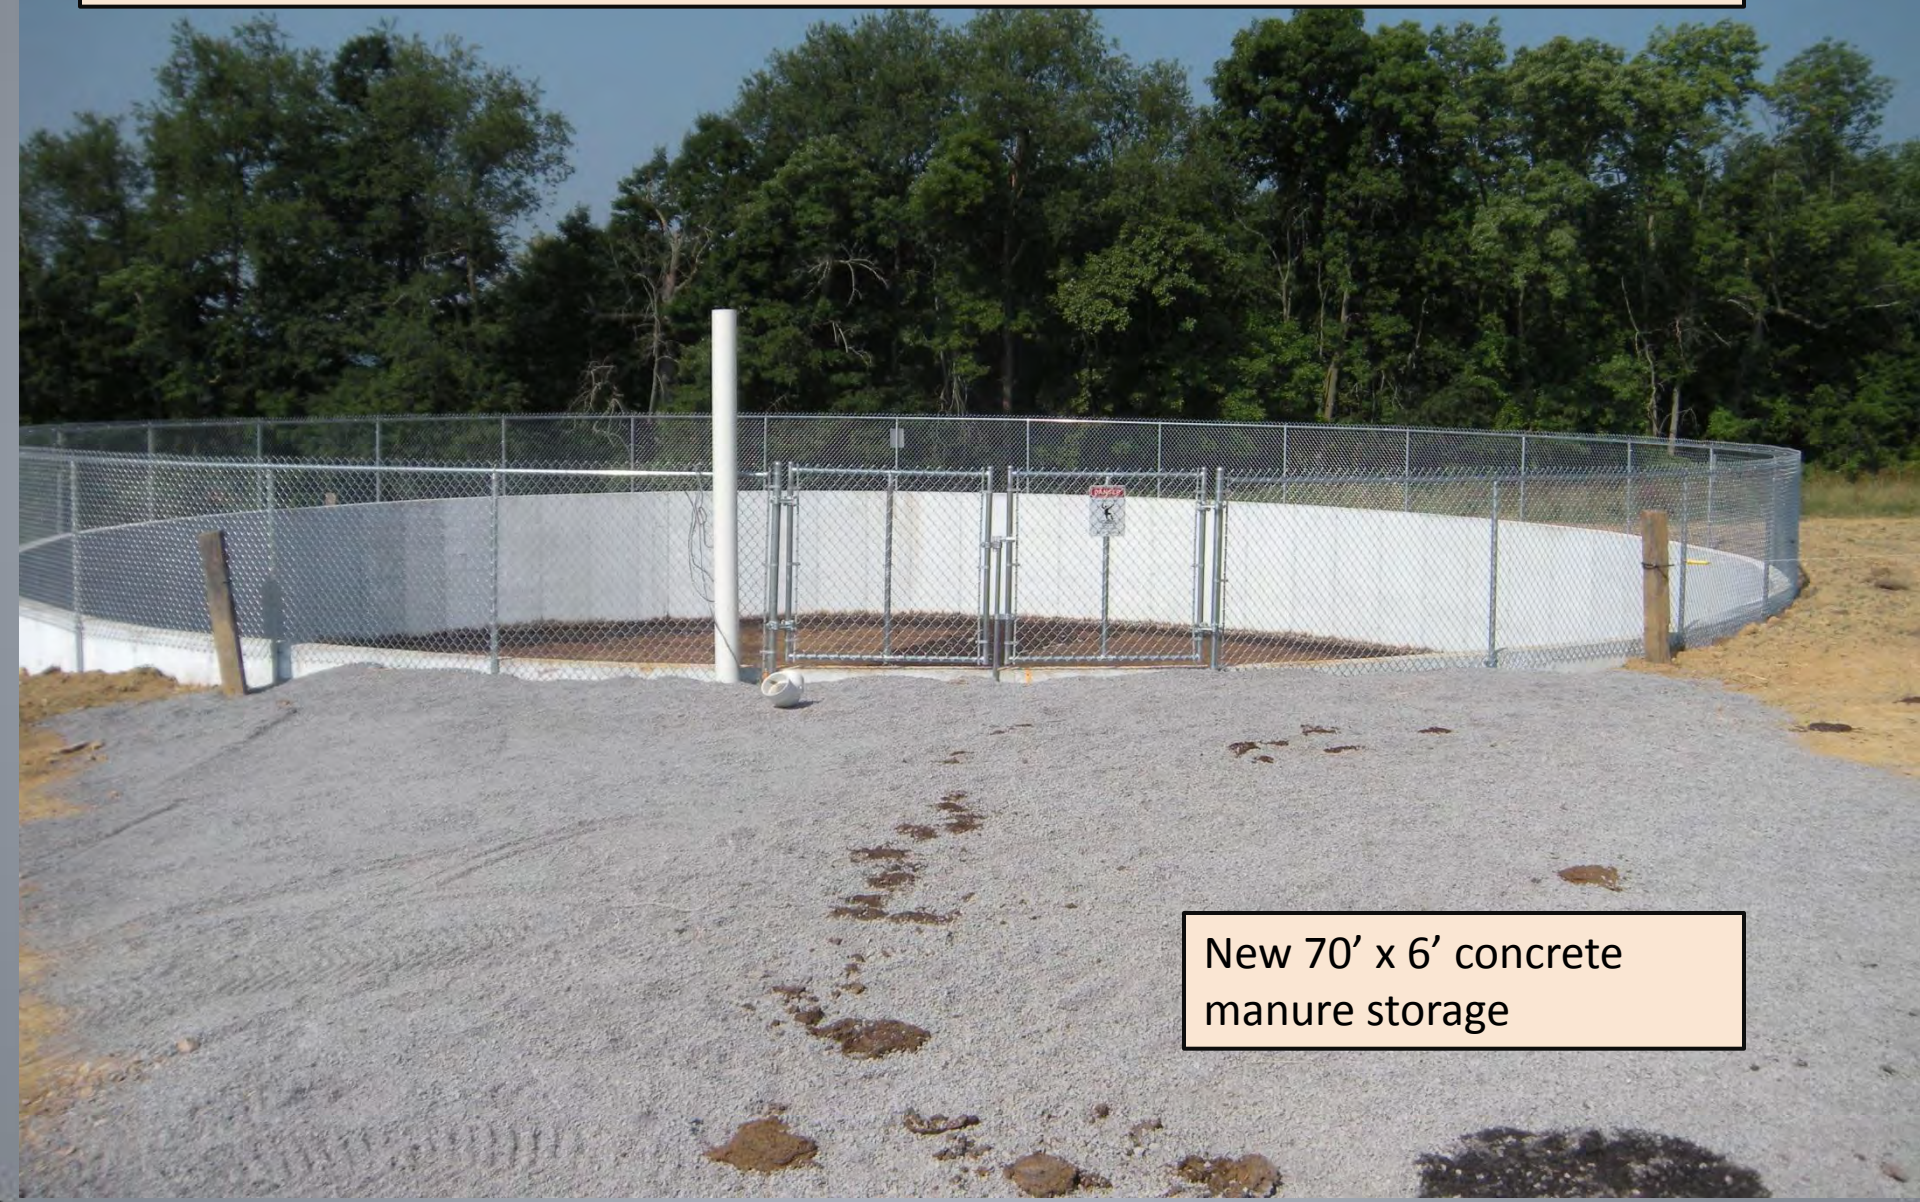
New 70' x 6' concrete
manure storage

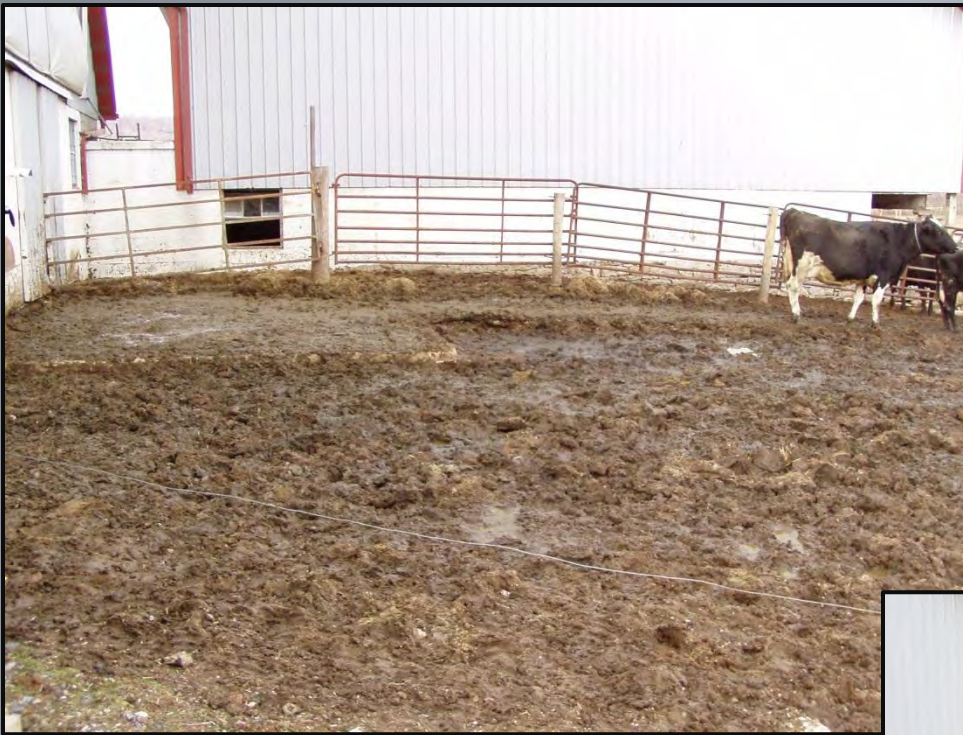
Animal concentration area (ACA) before BMPs were installed. An existing manure storage is located below the ACA. Behind the manure storage is a small tributary to Little Fishing Creek

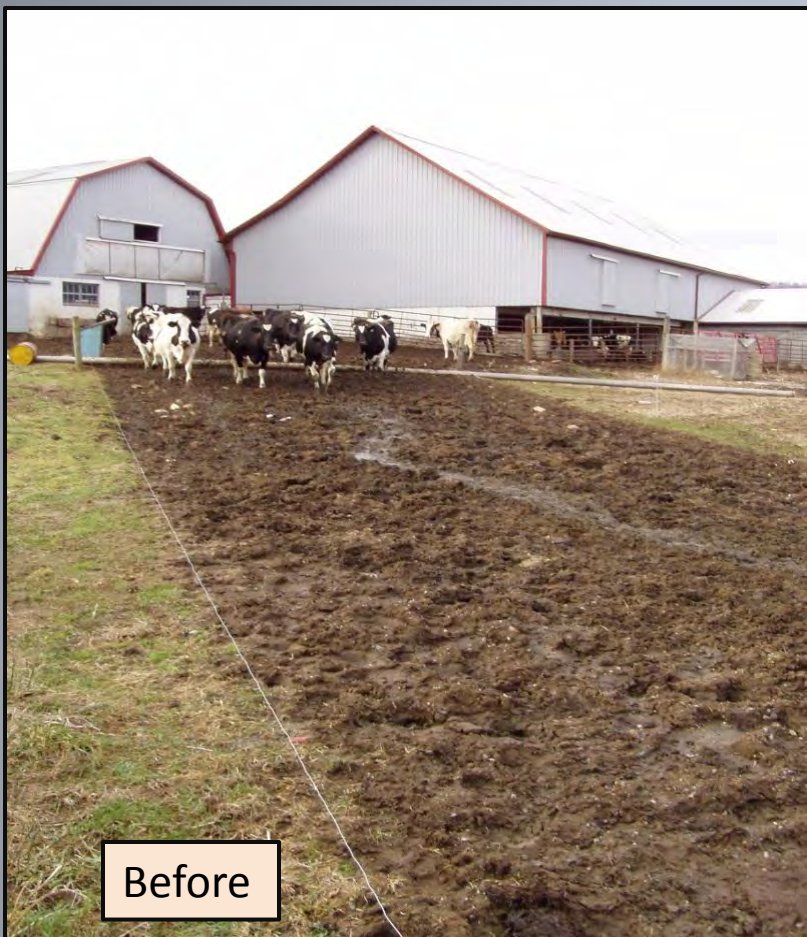
Before

Runoff from the ACA travels down the cattle walkway and enters a small tributary to Little Fishing Creek.

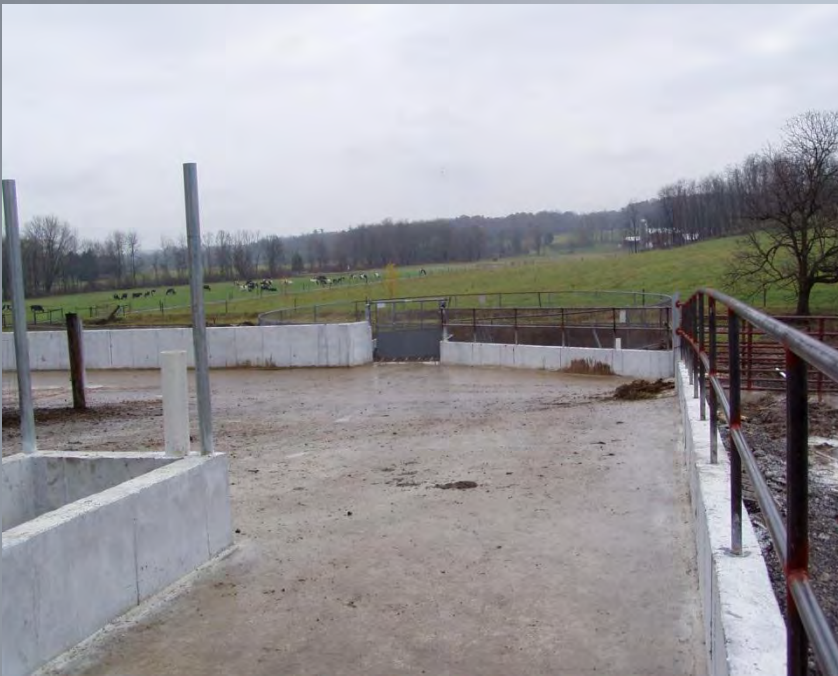
All runoff is contained on the concrete lot and is directed into the manure storage. A push-off ramp enables solids to be pushed into the storage.

The intent of this project was to address runoff concerns from an existing Animal Concentration Area (ACA). The first step in this process was to minimize the size of the concentrated area. The cows were excluded from approximately 1 acre of the area closest to a small tributary to Little Fishing Creek. The landowner had already installed streambank fence, although with very little buffer. This area will only be used for flash grazing when vegetation is adequate. The remaining area was stabilized with concrete and curbing. All the runoff was directed into an existing manure storage.

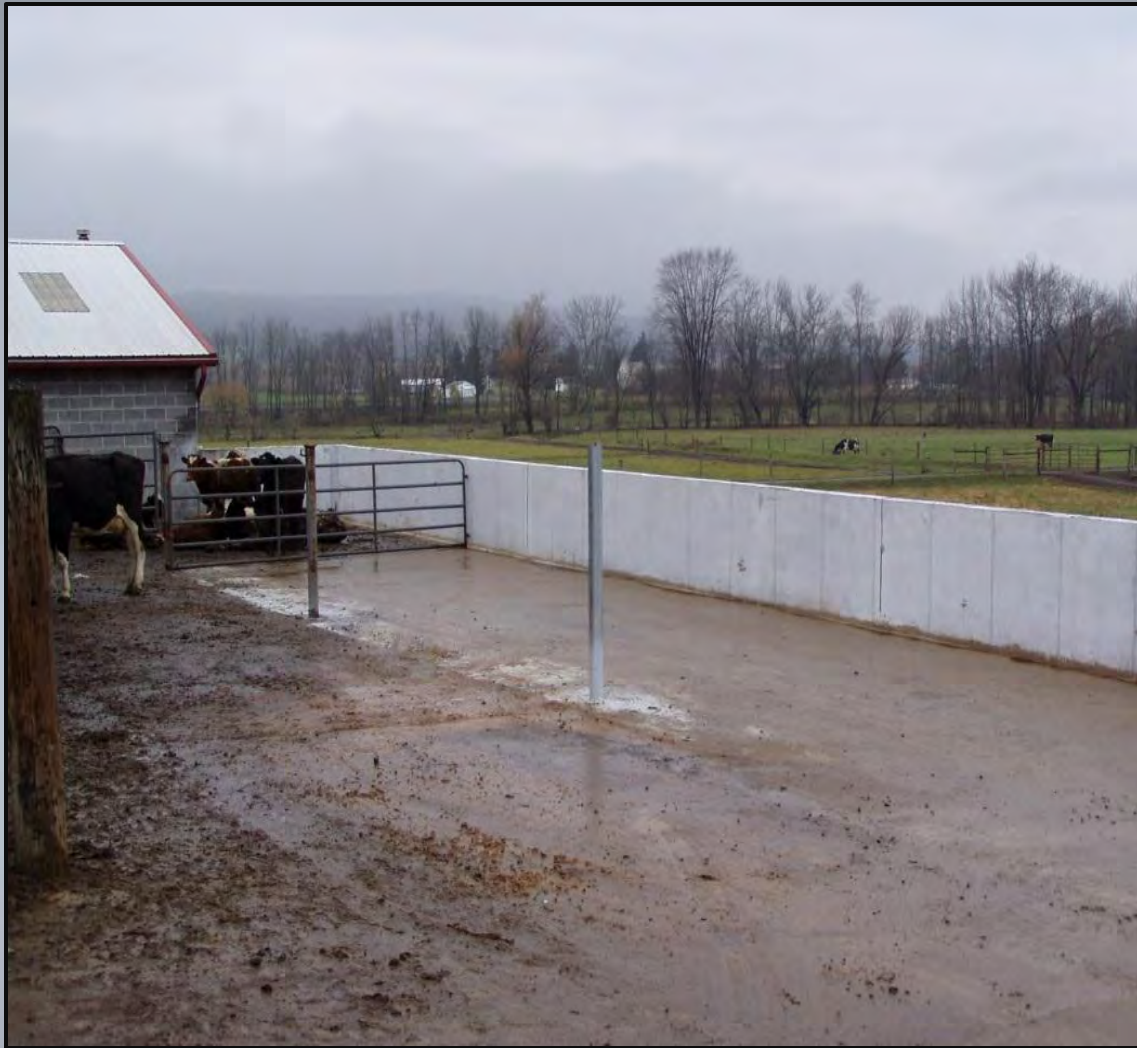
A 4 foot high wall was constructed along the east end of the lot to enable stacking of manure.

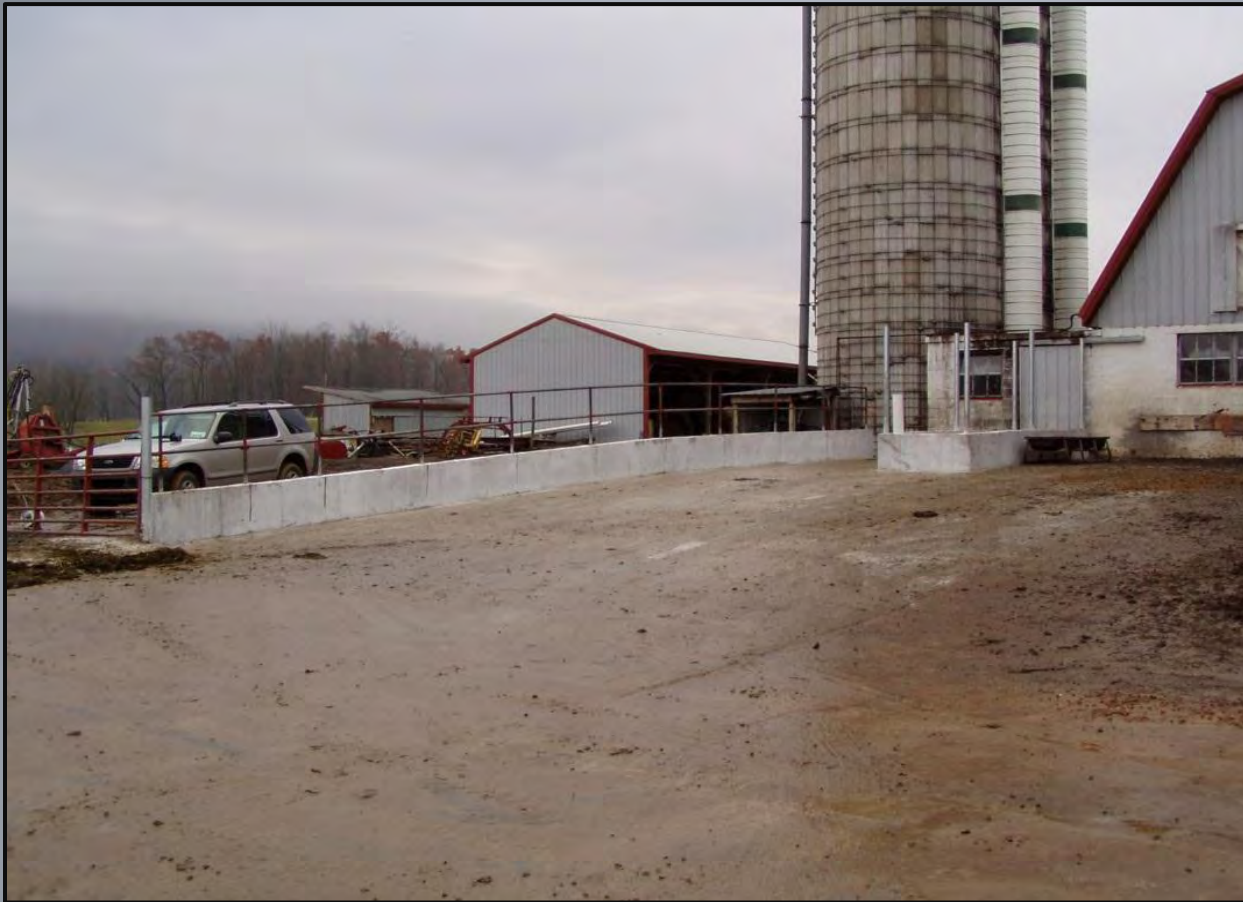
Leachate from the silo pictured here was collected and piped to the storage .
