Watershed Assessments

UPPER SCHUYLKILL RIVER TMDL WATERSHED IMPLEMENTATION PLAN (WIP)

Big Creek Watershed Coldwater Conservation Plan

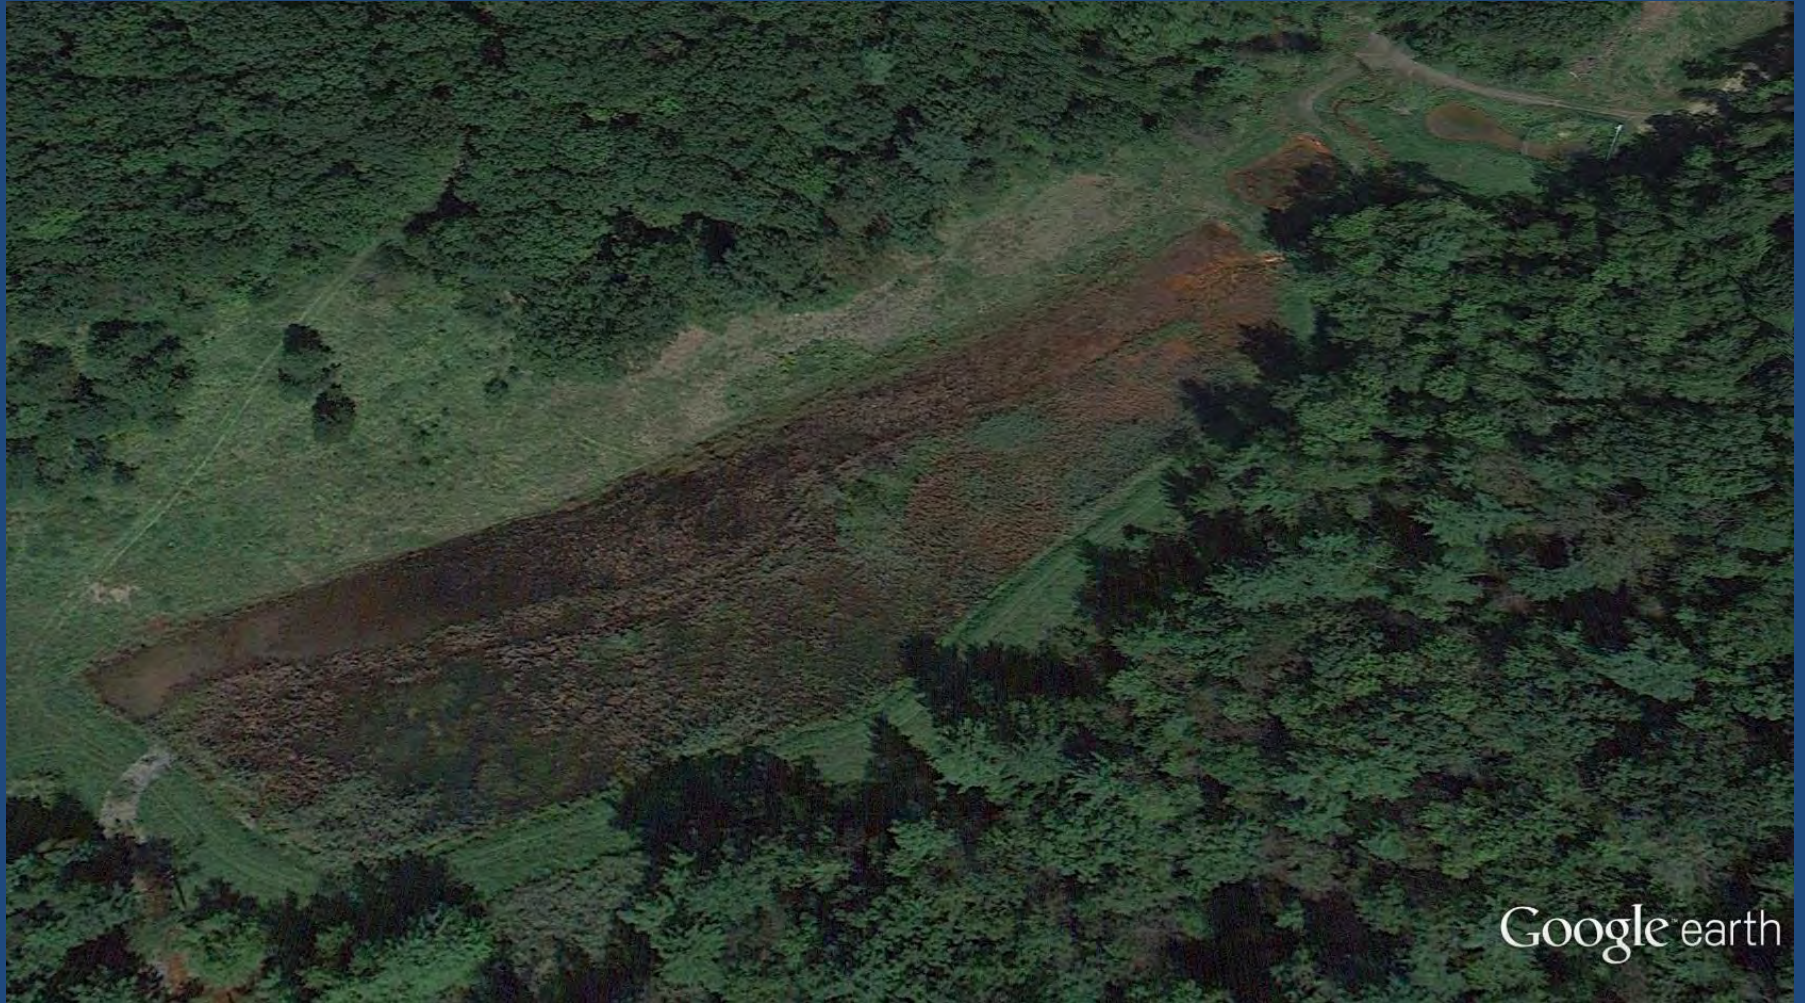
Mary D Overflow

Mary D Borehole

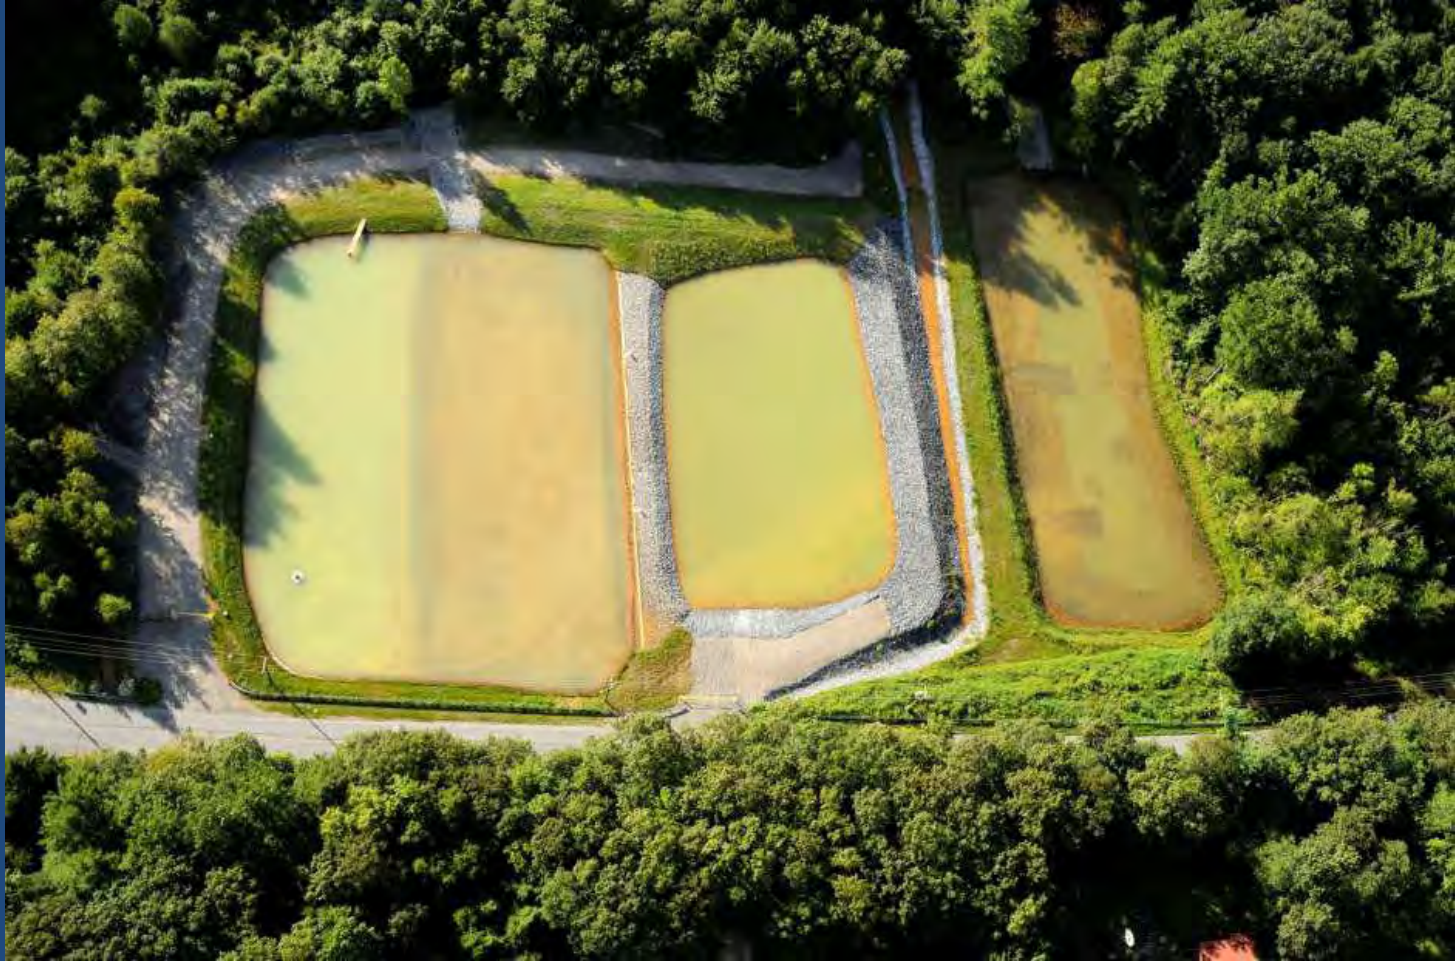
On line June 10, 2013

- Avg. flow:
- 689 gpm
- Raw water:
- Fe – 7.2 ppm
- pH – 5.5
- Treated water:
- Fe – 1.0 ppm
- pH – 7.5
- Iron removal:
- 30.5 lbs./day -- 11,130 yr.

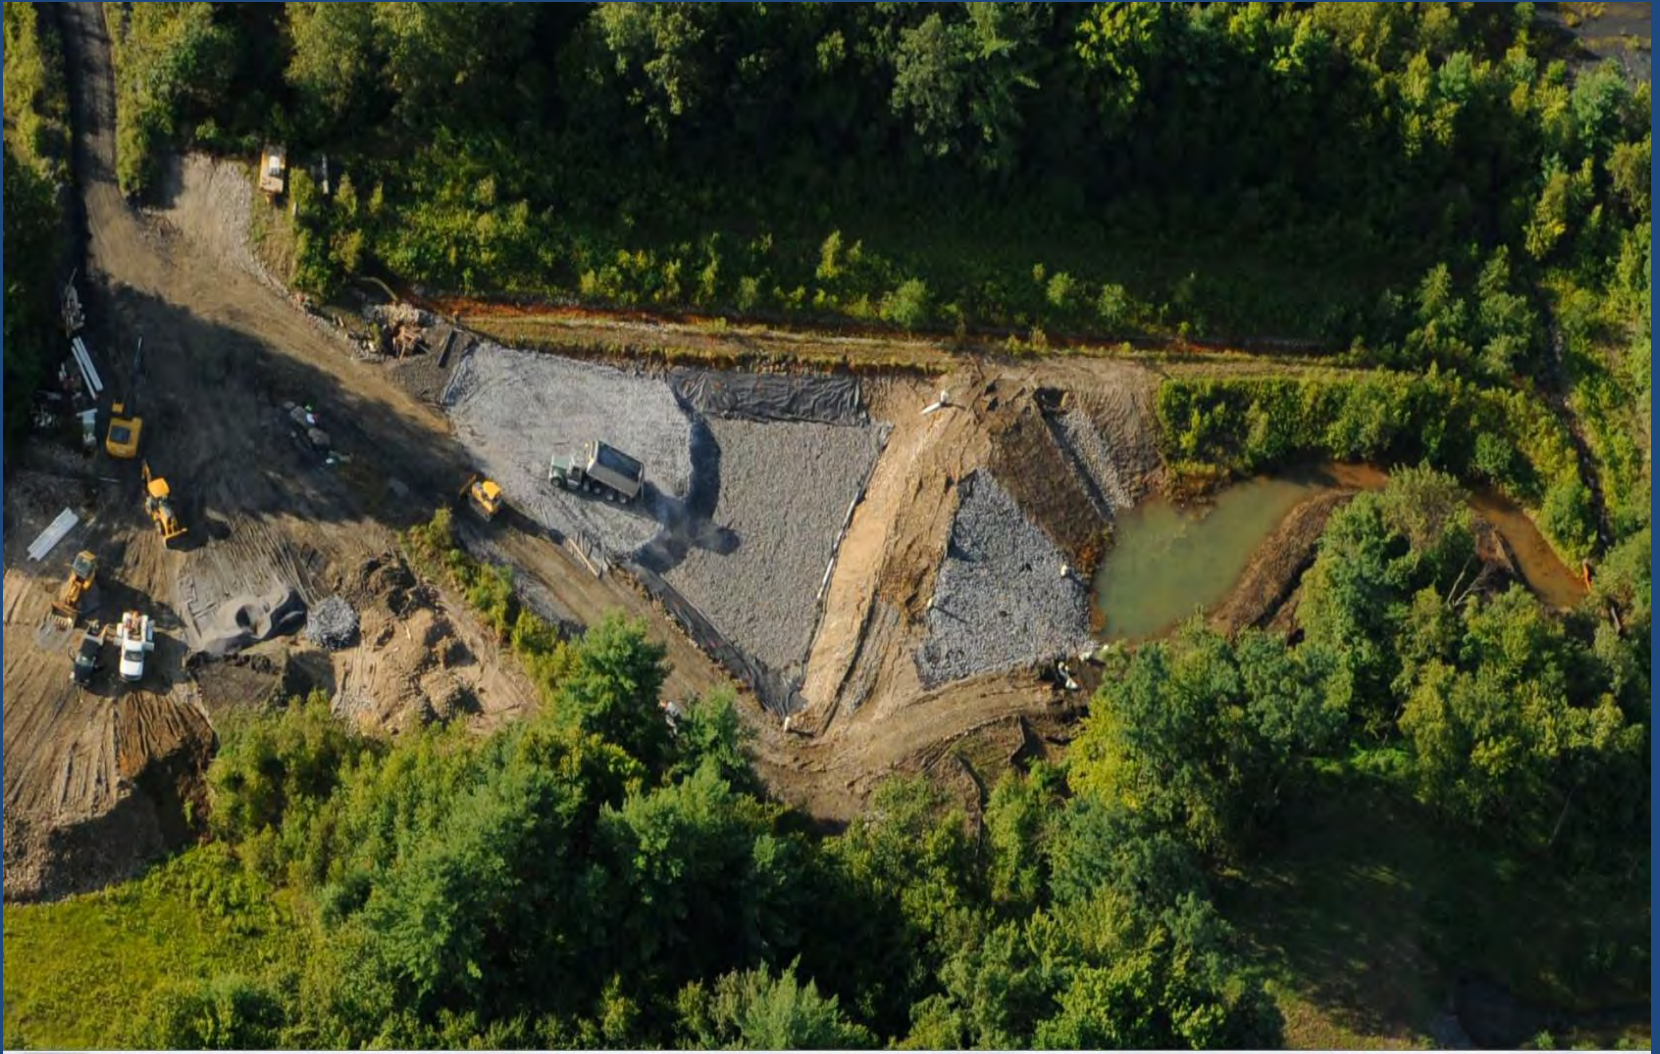
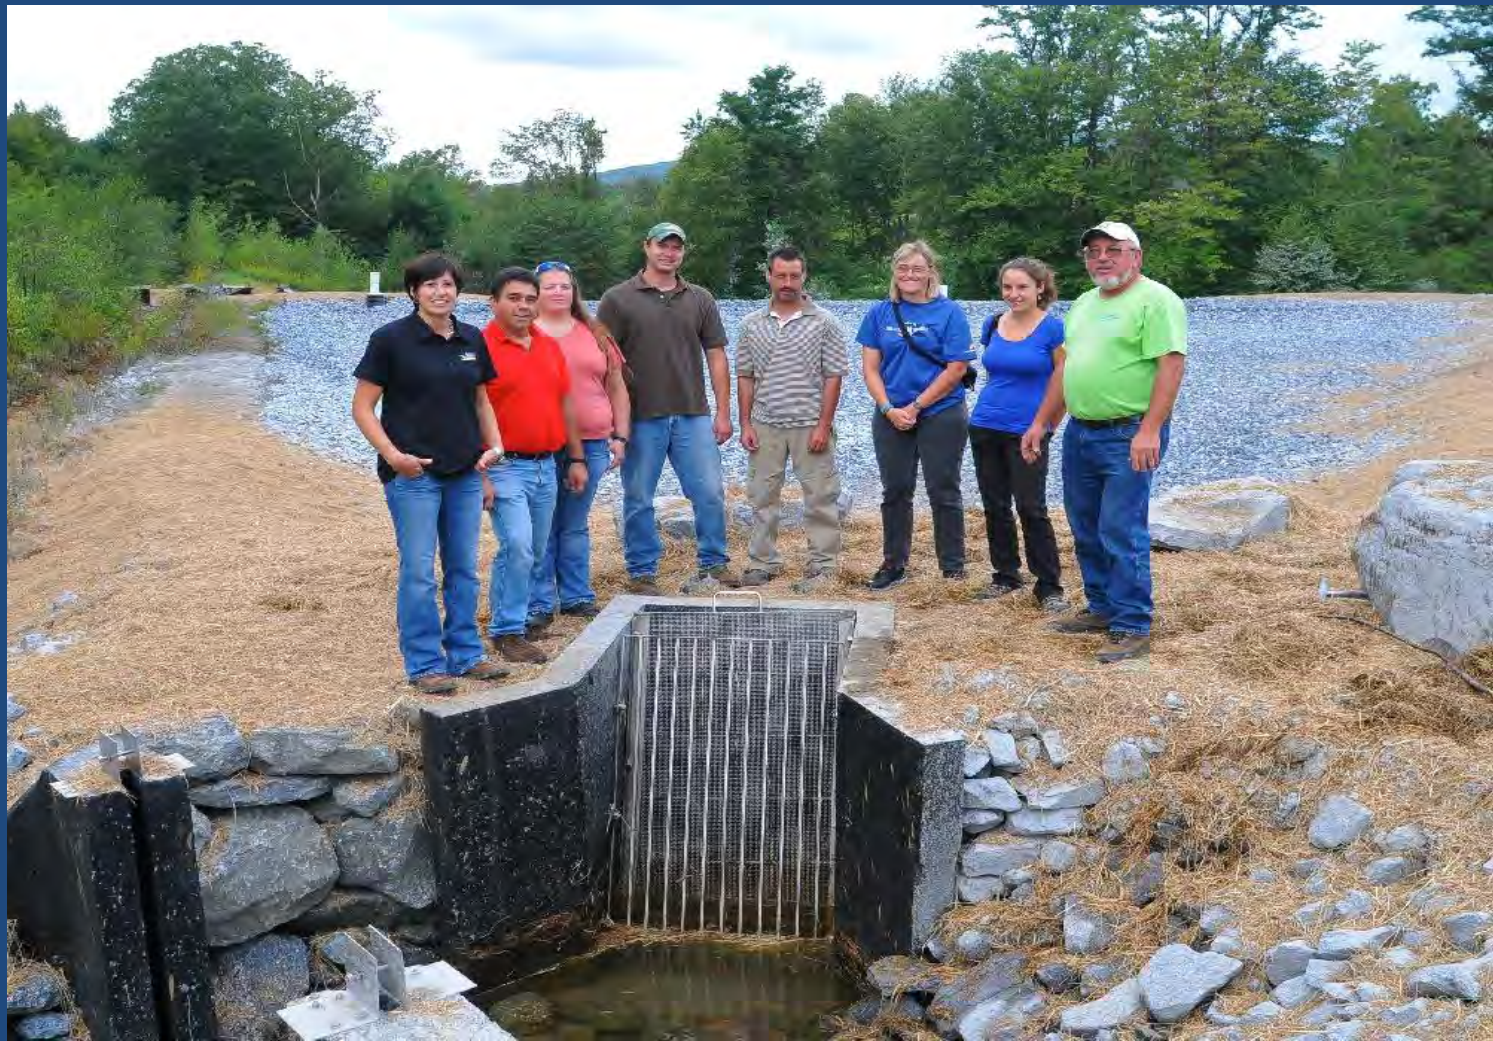
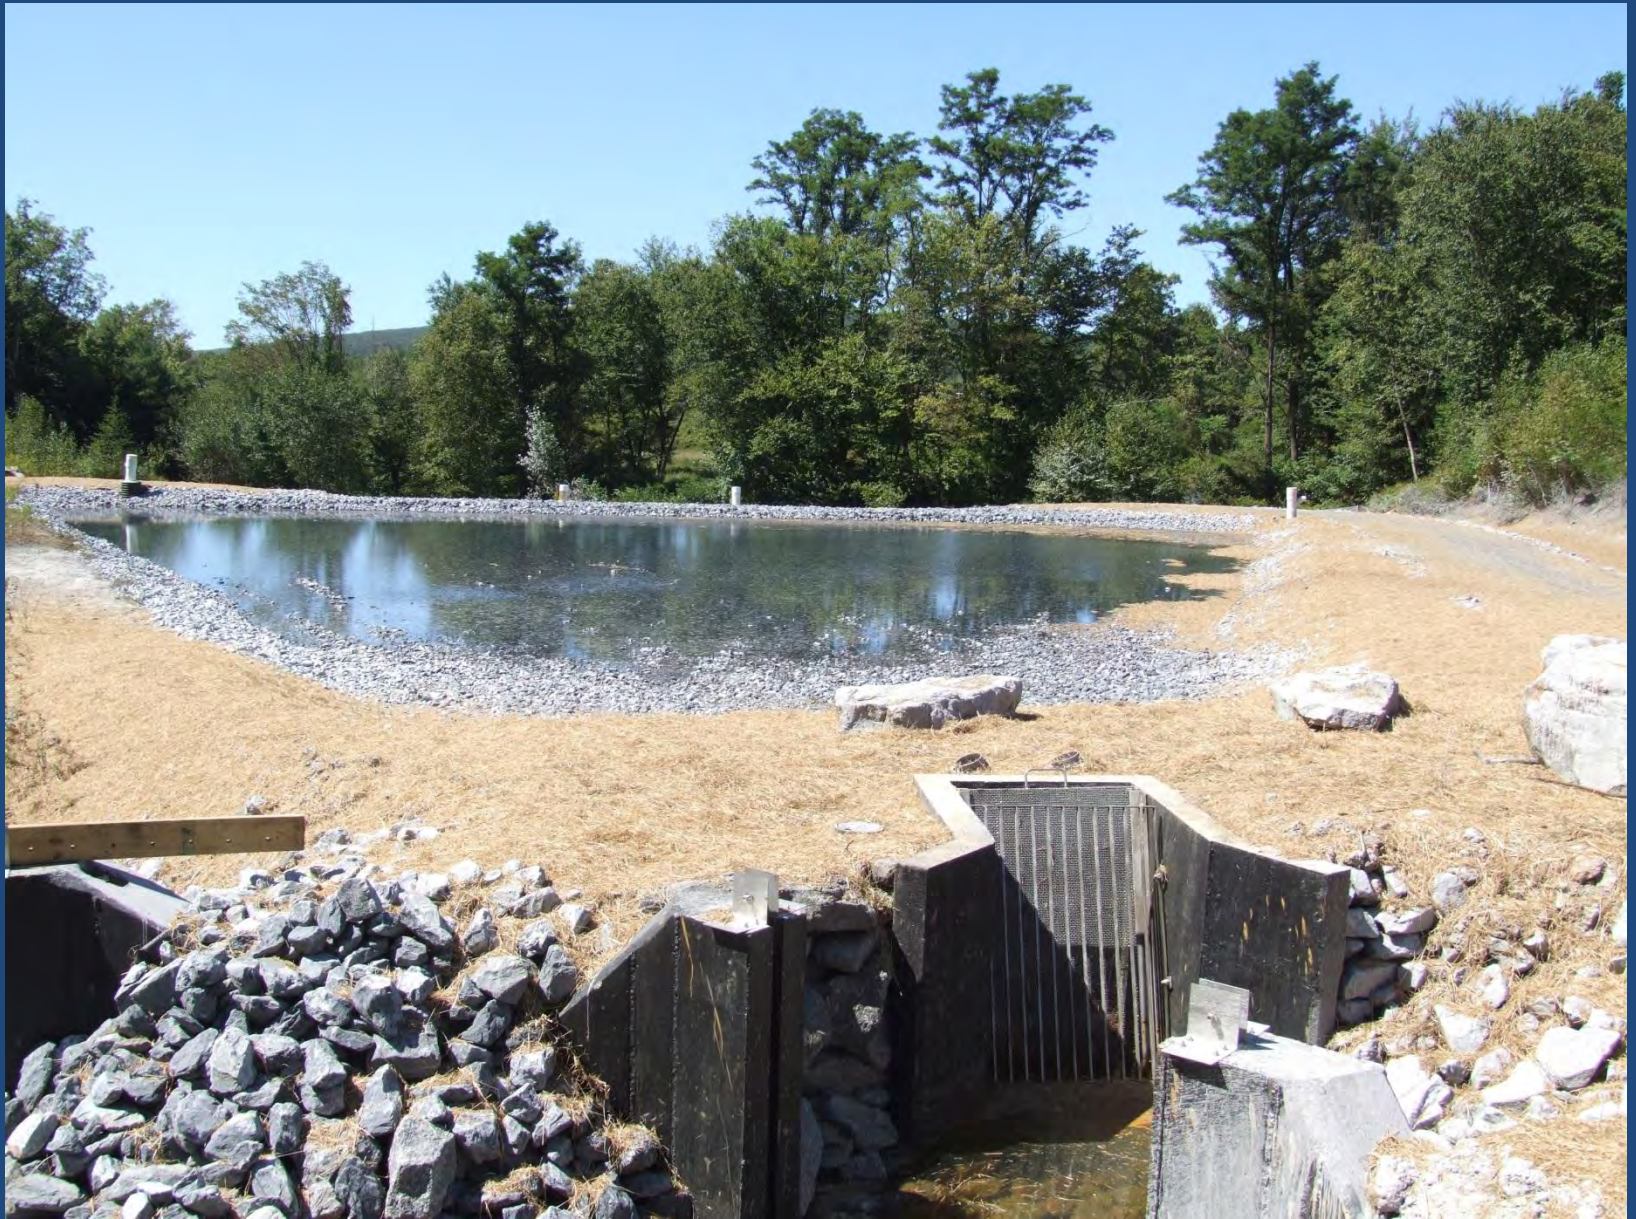
Bell Colliery

On-line September 5 2013

- Avg. flow:
- 281 gpm
- Raw water:
- Fe – 2.99 ppm
- pH -- 4.3
- Treated water:
- Fe – 1.08 ppm
- pH – 7.0
- Iron removal:
- 9.7 lbs. / day -- 3540 yr.

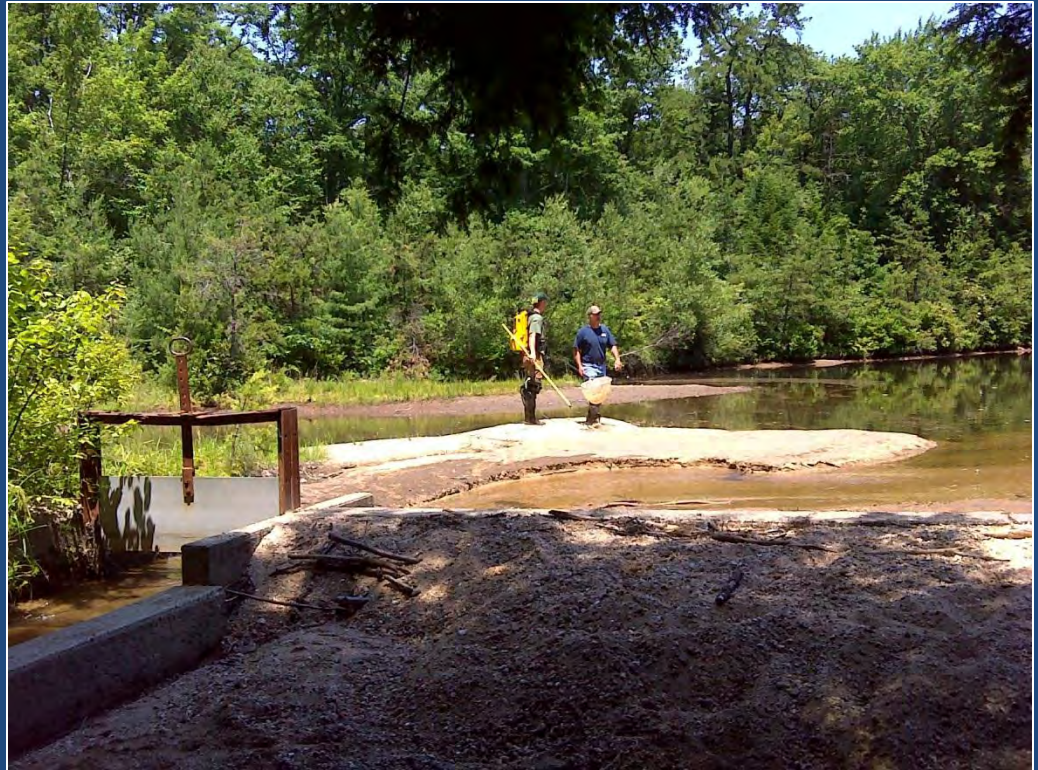
Sample Points

- Our study included nine sample points throughout the watershed
- Parameters:
 - **Water Quality**
 - **Macroinvertebrates**
 - **Fish**

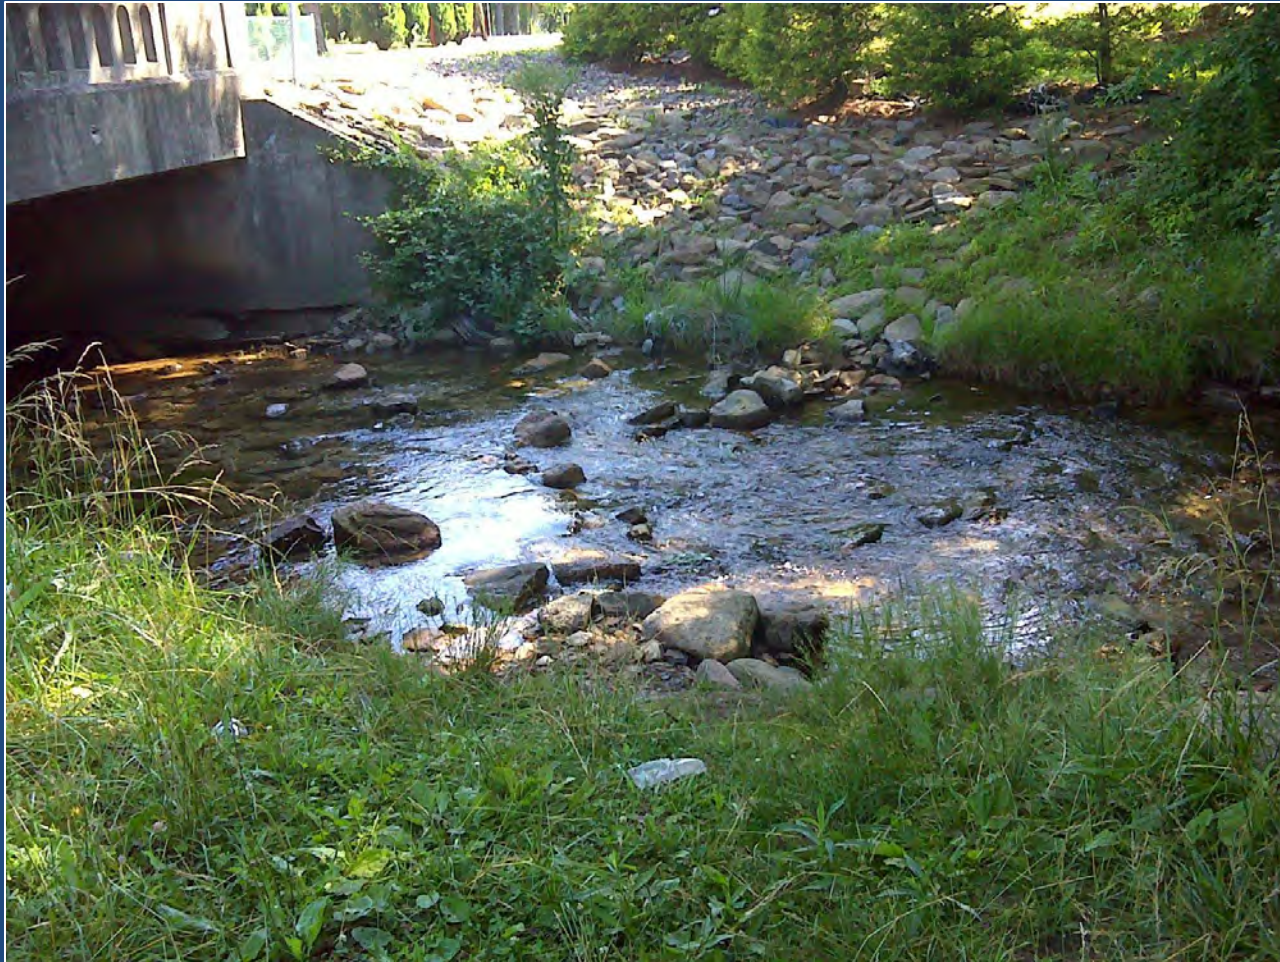
- One small brook trout at Sample Point #1
- Very poor due to low pH and lack of reliable food source
- Few crayfish, frogs, and salamanders observed

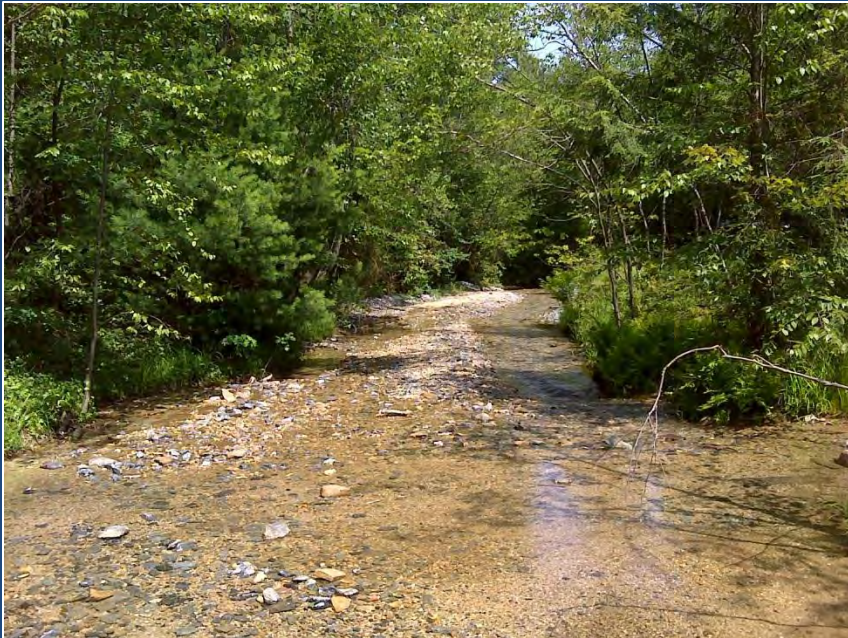
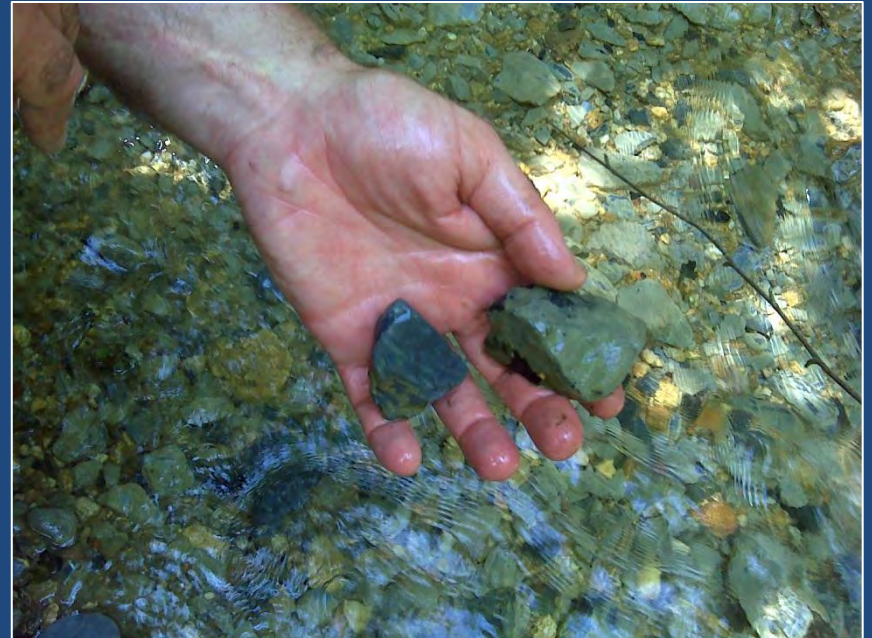
- **Big Creek Headwaters Area**

- Big Creek originates at an abandoned stripping pit
- Prior stream restoration project has been moderately successful
