IMPLEMENTATION OF STORMWATER BMPS IN THE LAKE LUXEMBOURG / CORE CREEK WATERSHED, BUCKS COUNTY, PA

Fred S. Lubnow, Ph.D.

Princeton Hydro, LLC

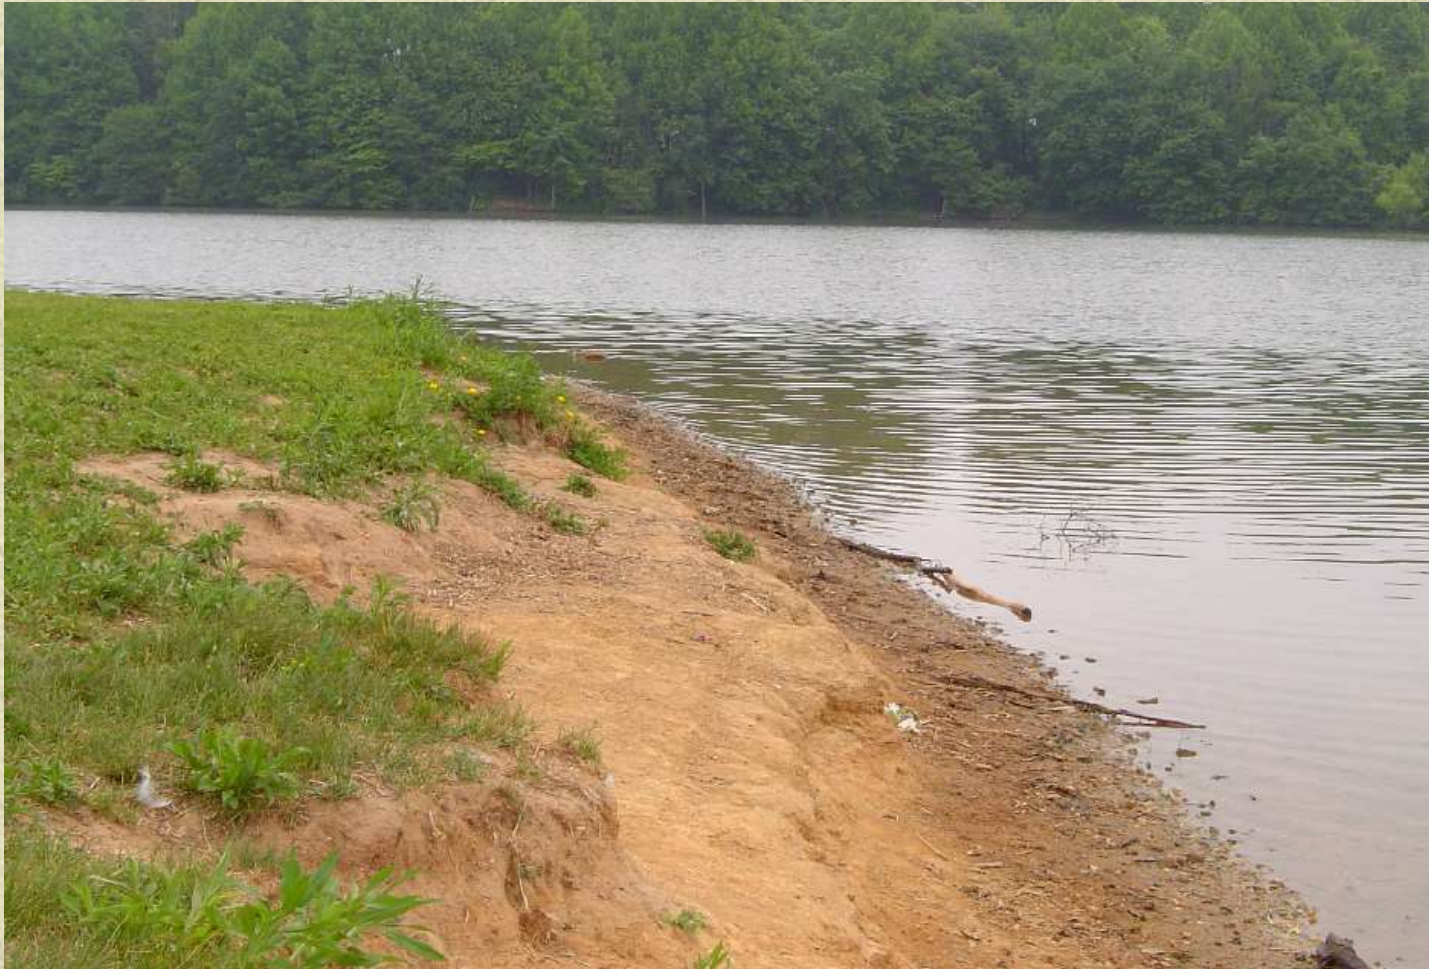
Eroded shoreline - 2000

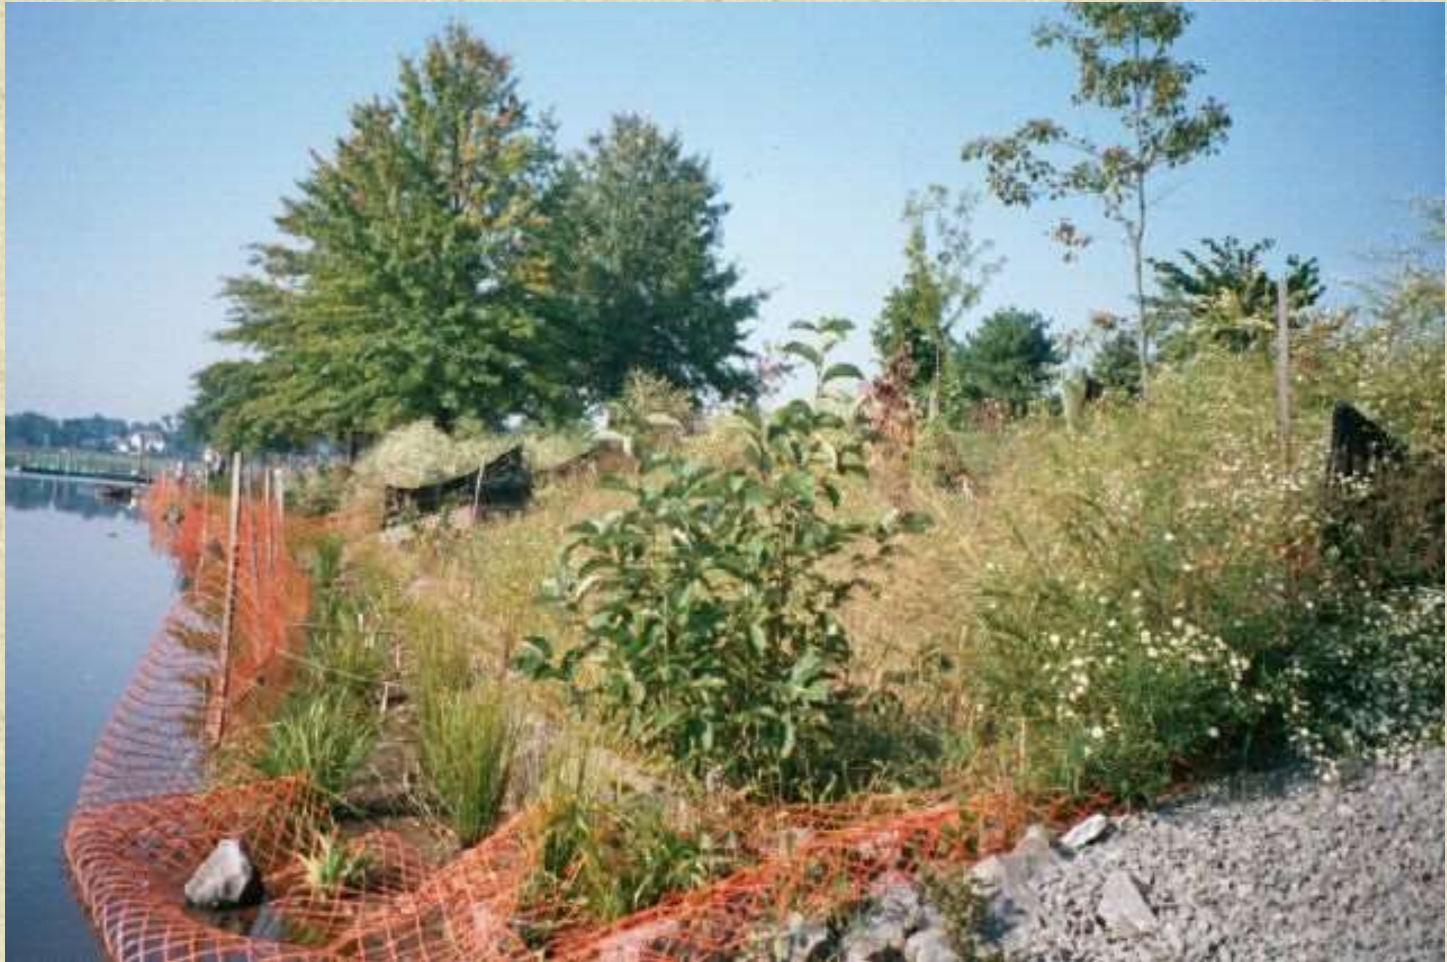
Shoreline vegetation project at Lake Luxembourg, mid-October 2001

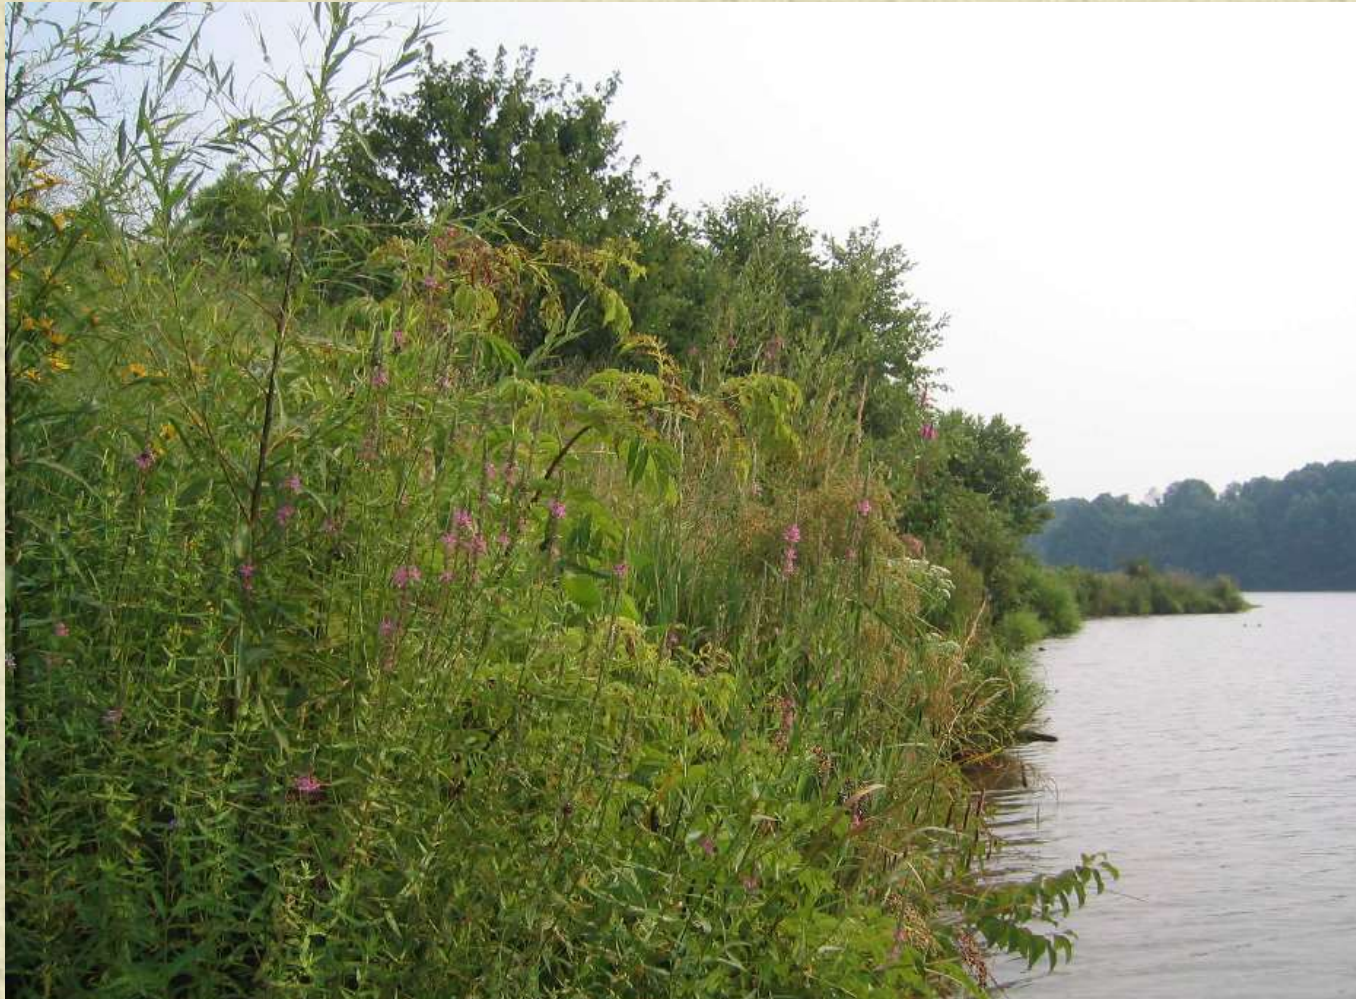
Shoreline vegetation project at Lake Luxembourg, late August 2005

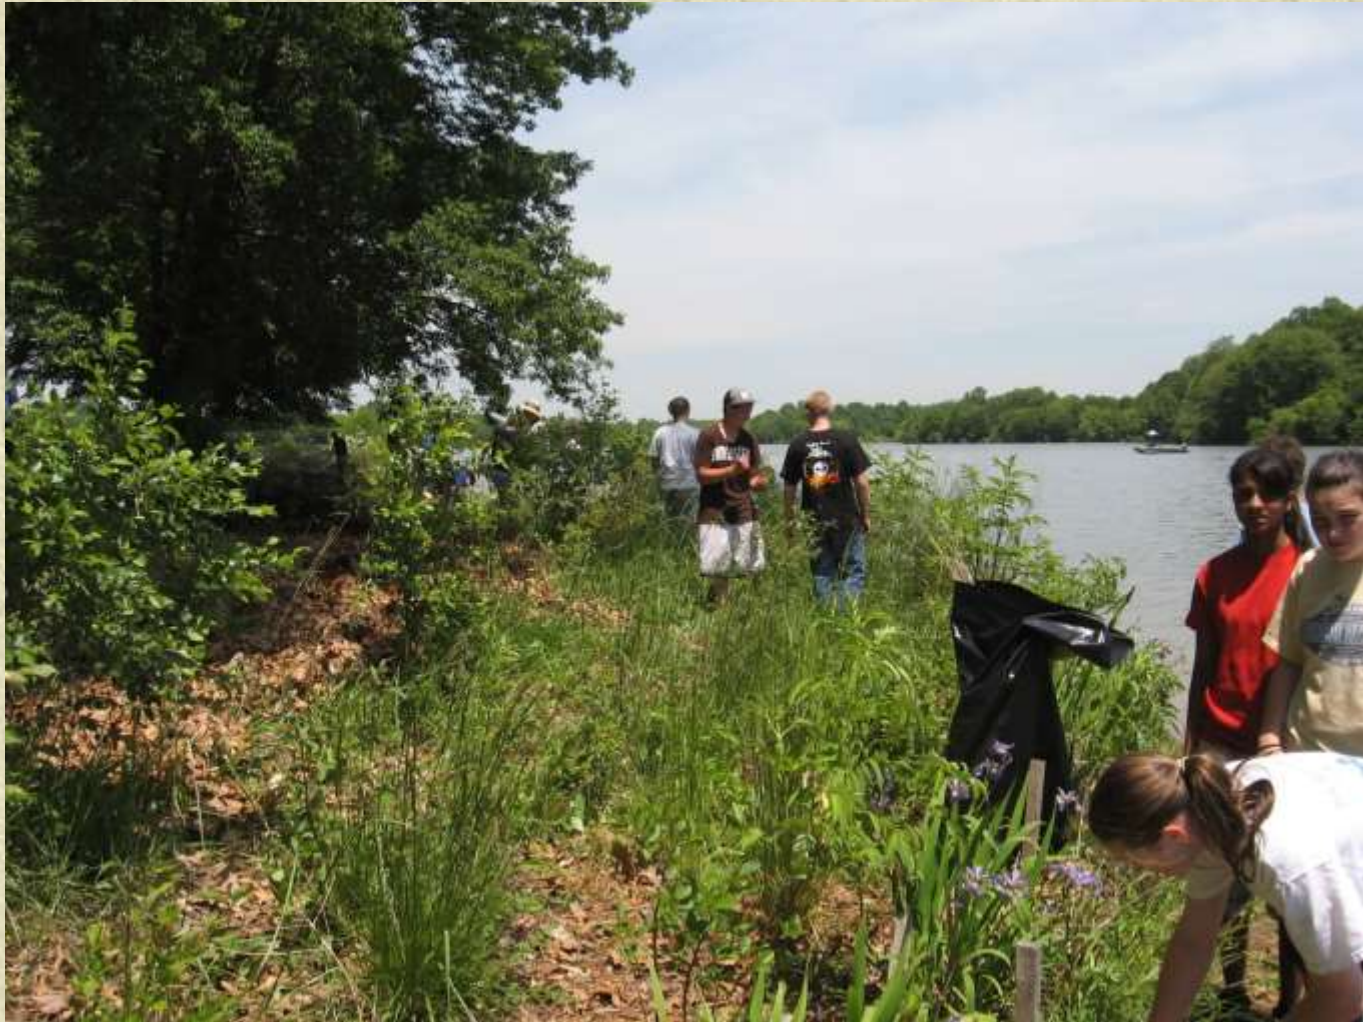
Second shoreline stabilization site

30 May 2008

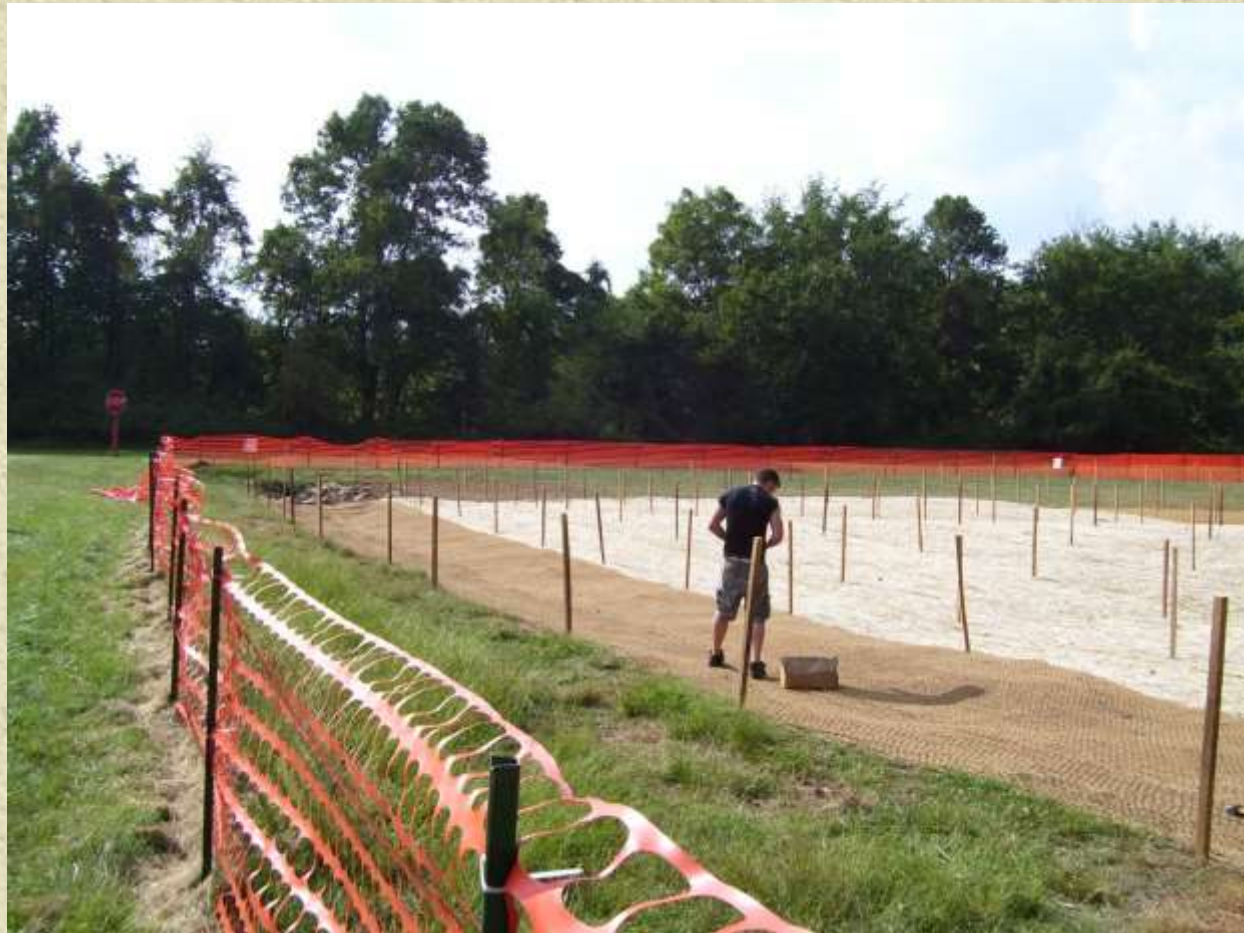
Construction of Pocket Wetland

26 September 2007

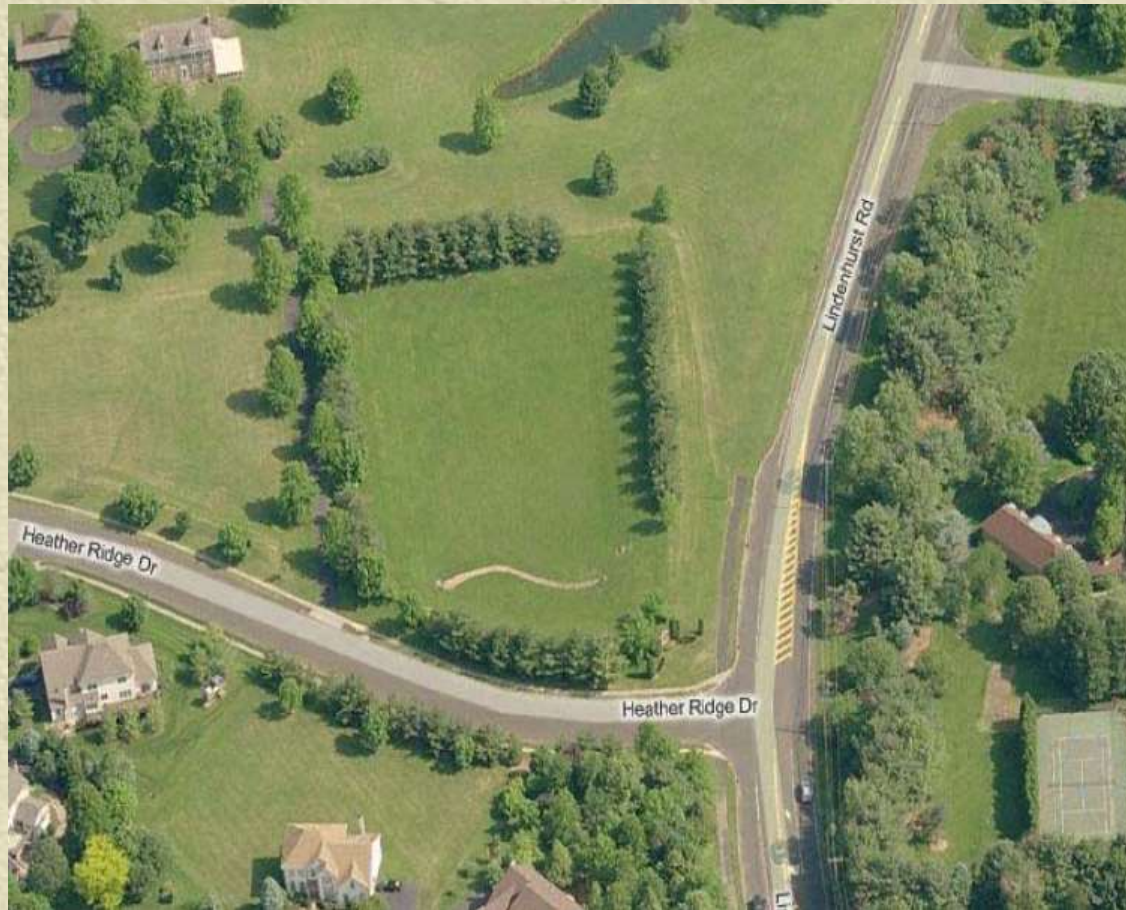
Removal of low-flow concrete channel at Heather Ridge Basin

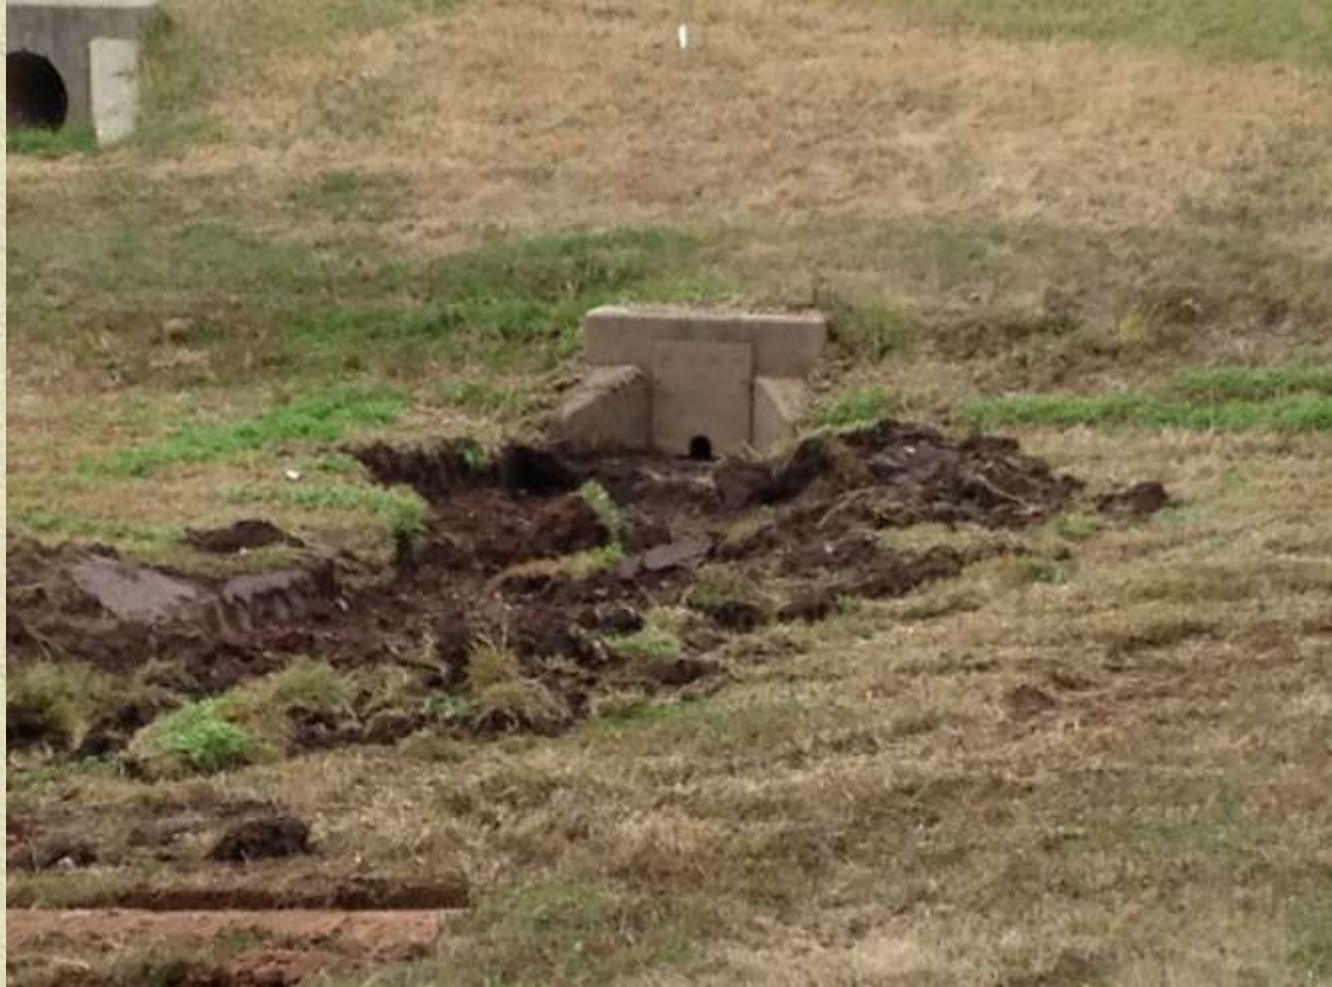
Heather Ridge Basin CC-E63 (June 2015)

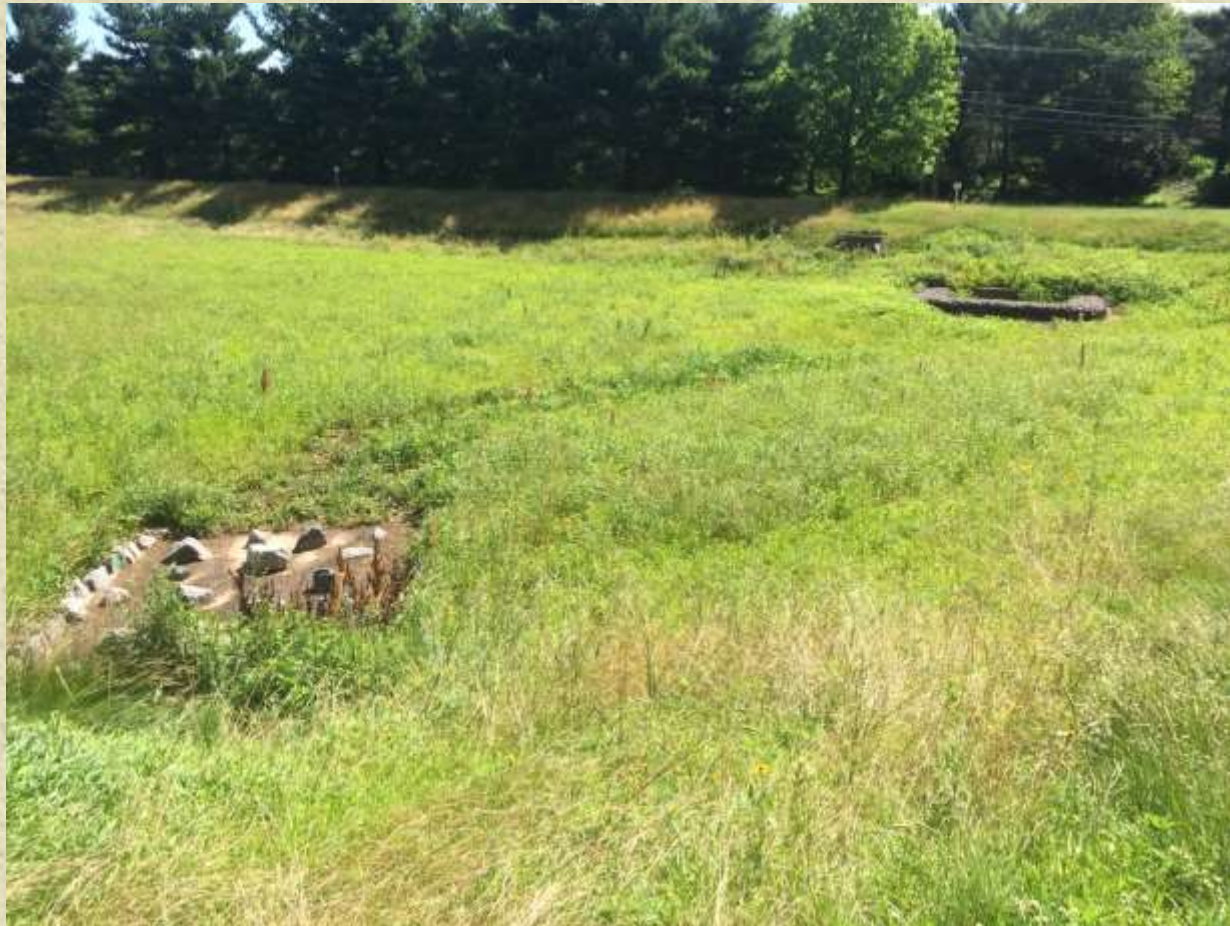
Heather Ridge Basin CC-F59 (June 2015)

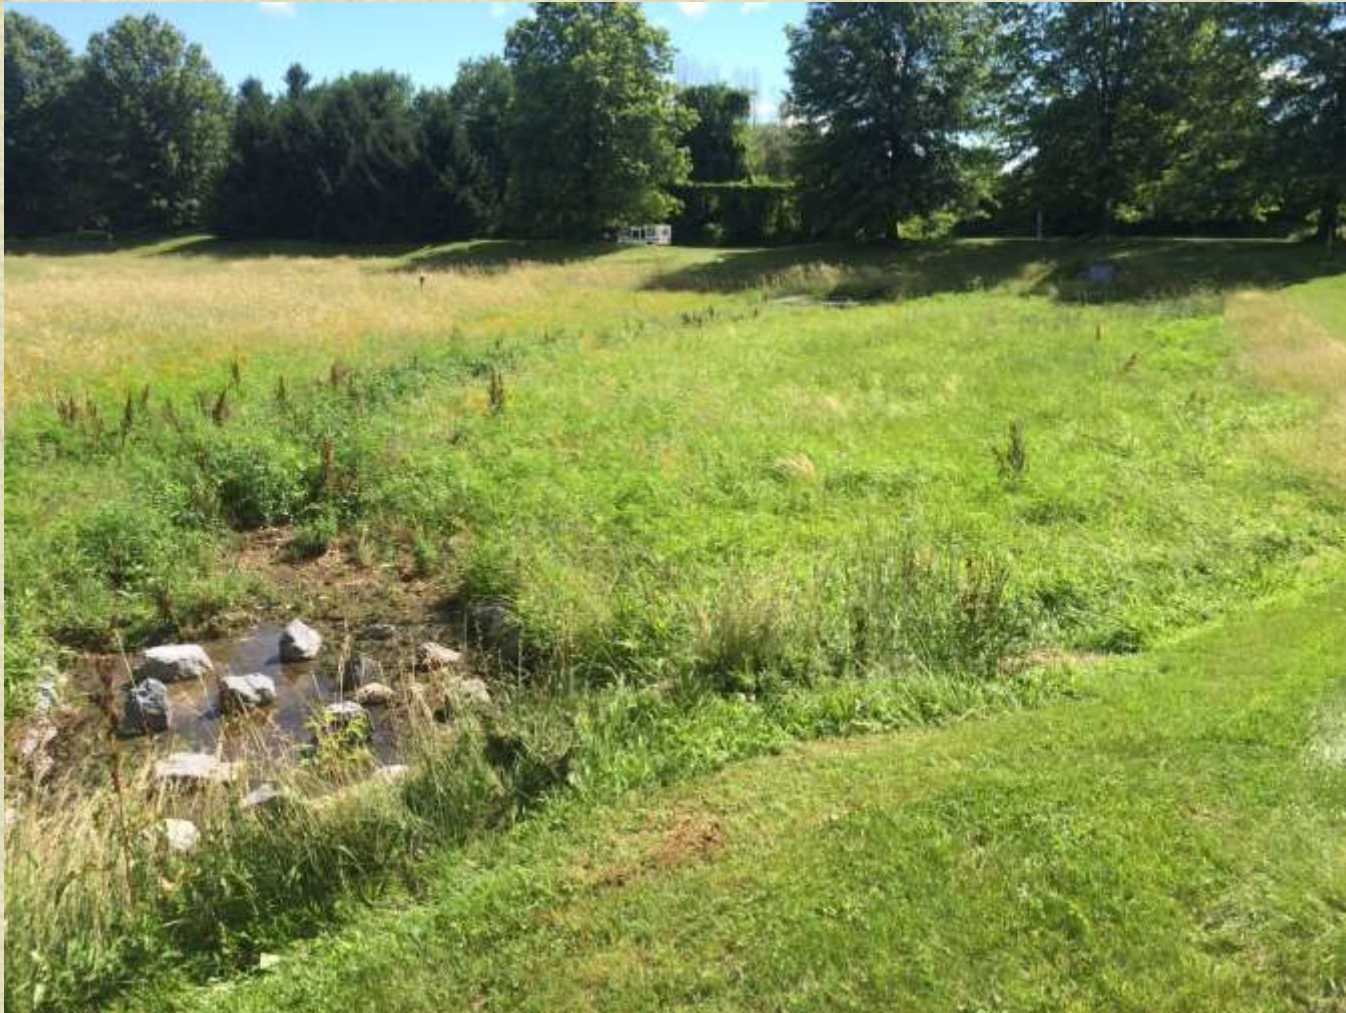
Yardley Run Basin CC-F57 (Lower Makefield; June 2015)

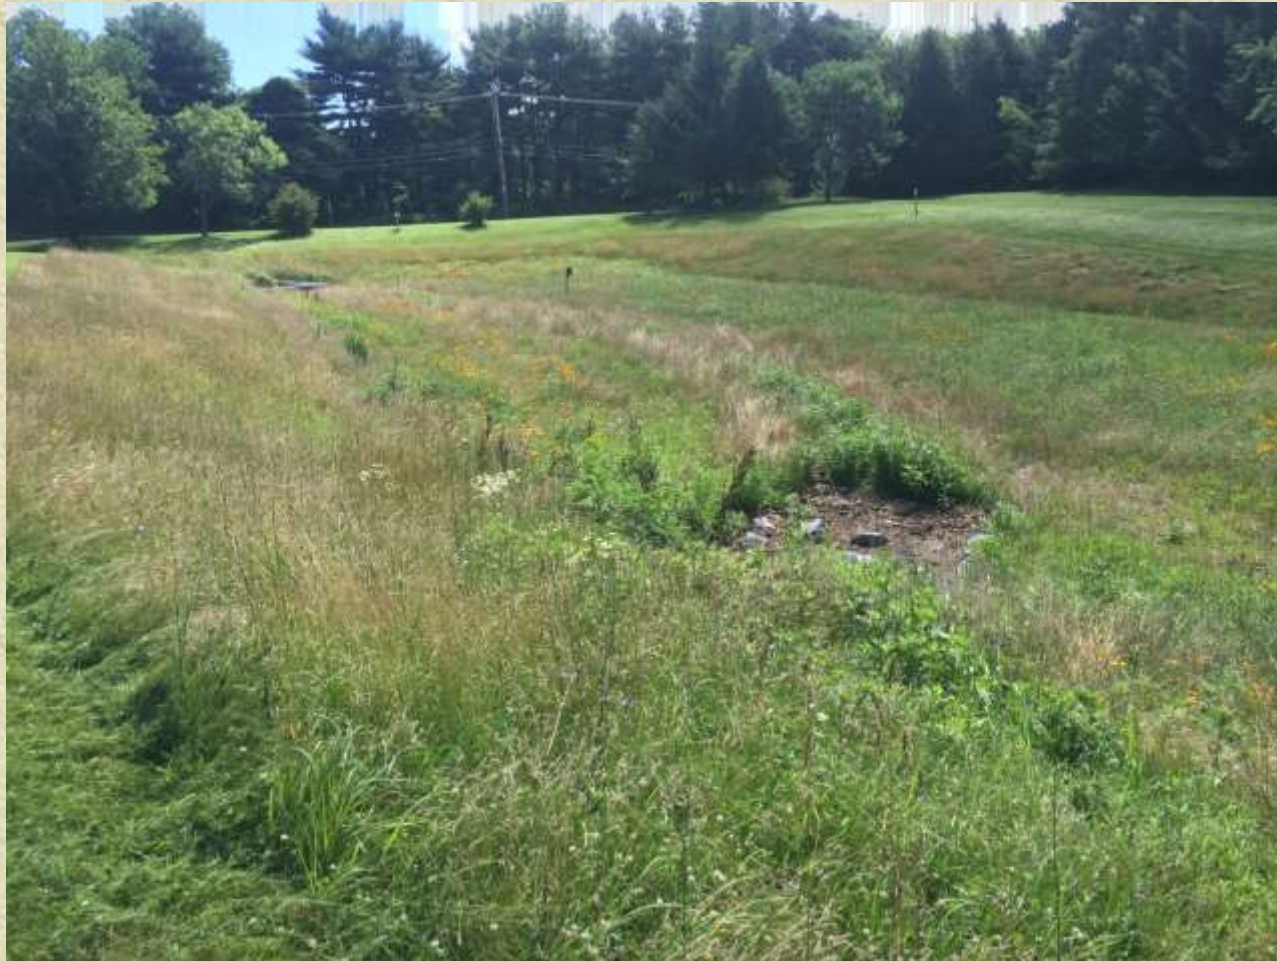
Nun Academy Basin CC-G54 (Lower Makefield; June 2015)

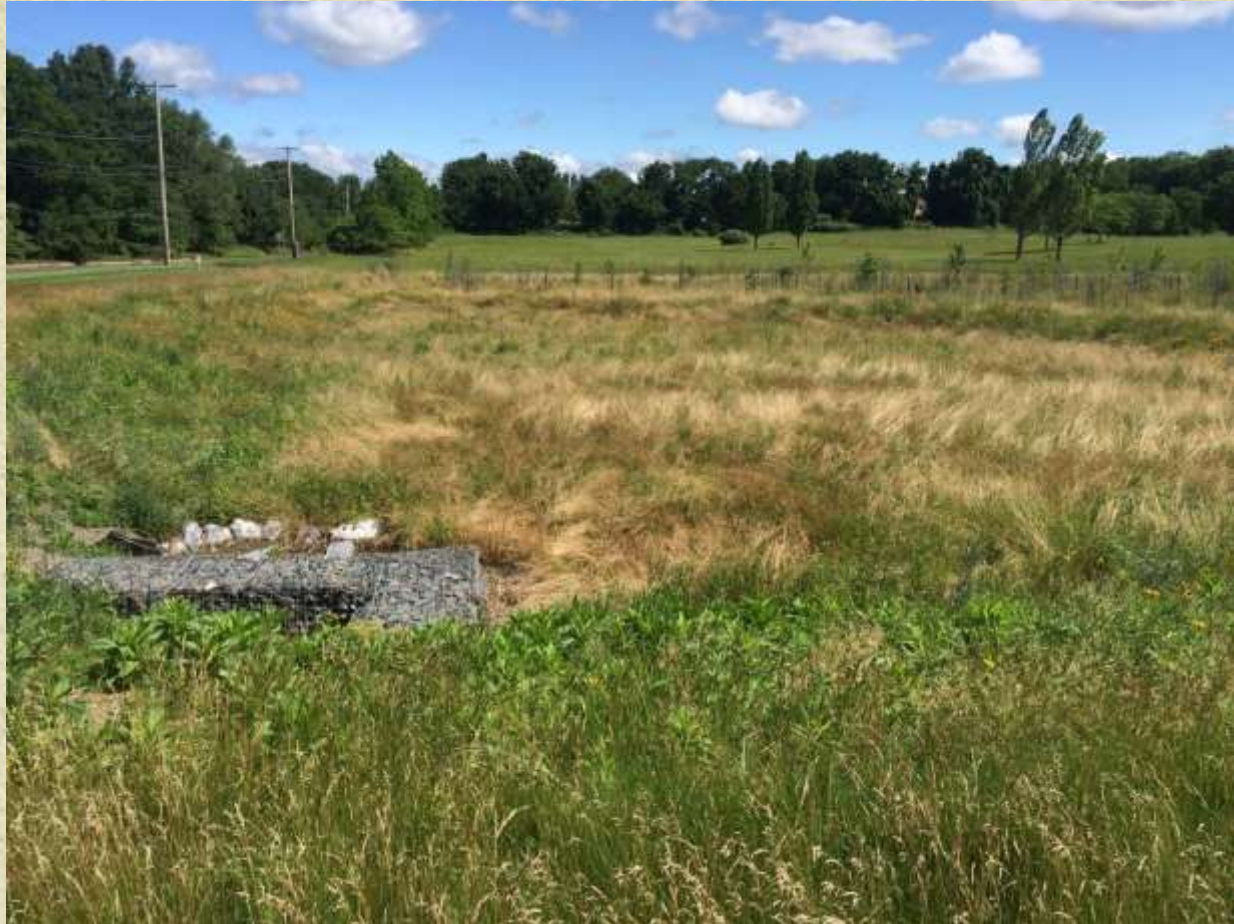
Eroded shoreline along southwestern corner of Lake Luxembourg (photo by BCCD)

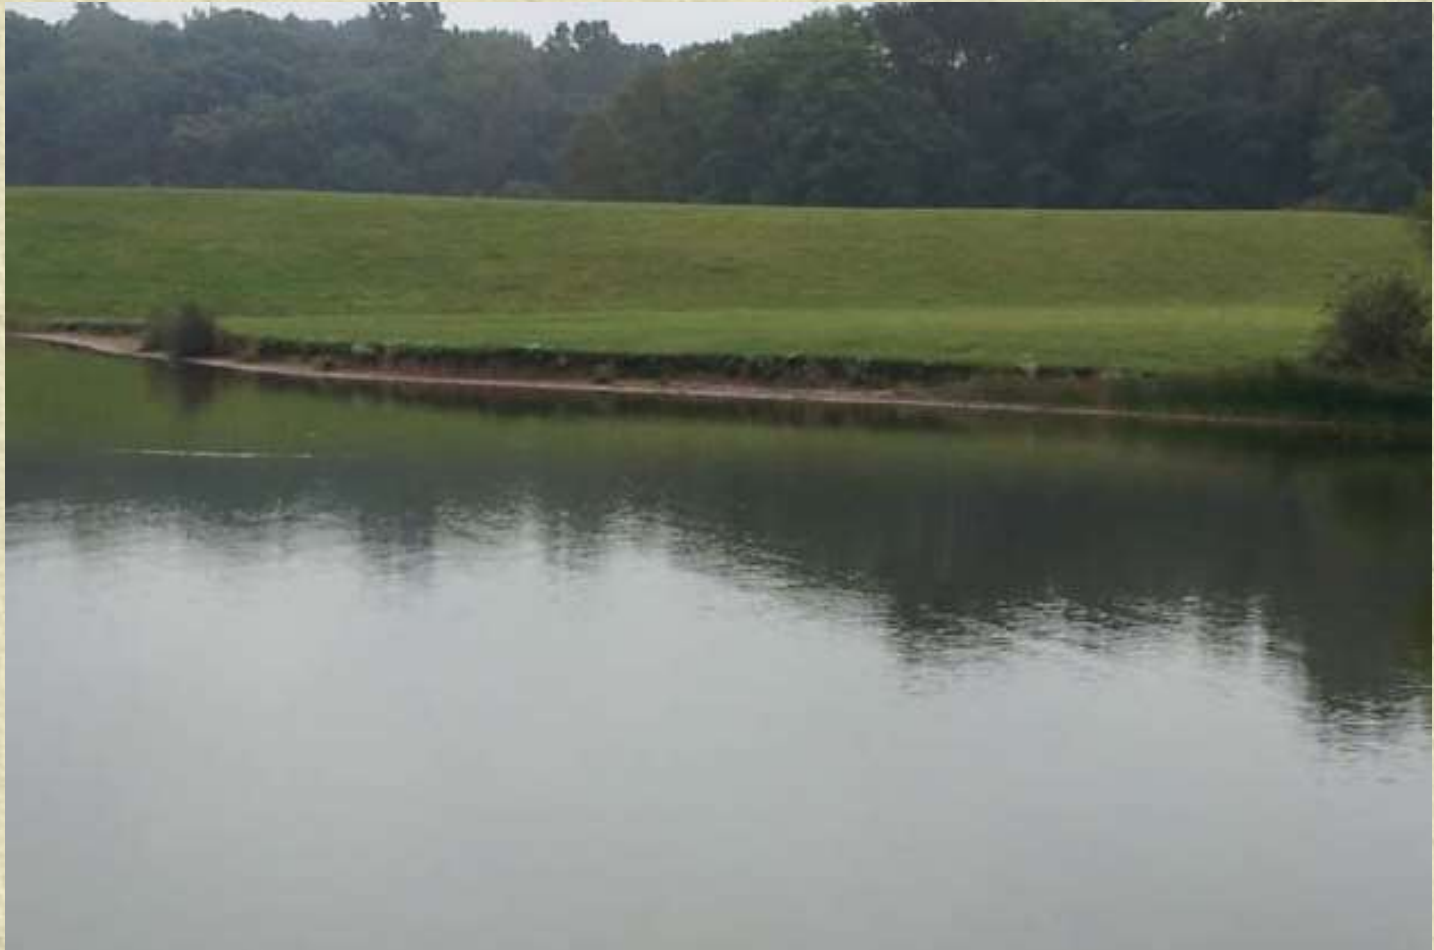
Re-grading the shoreline (September 2014)

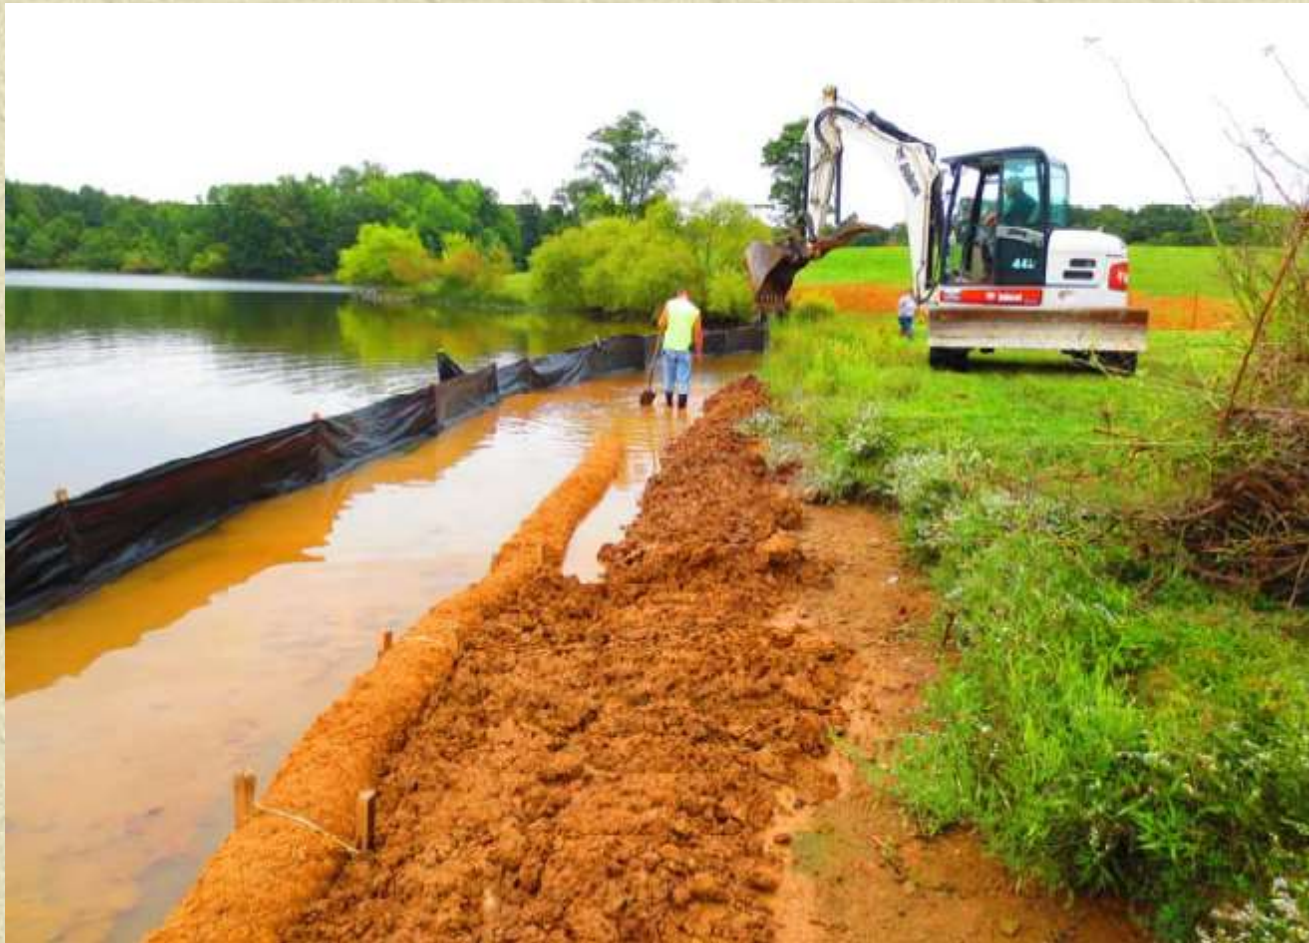
Re-grading the shoreline (September 2014)

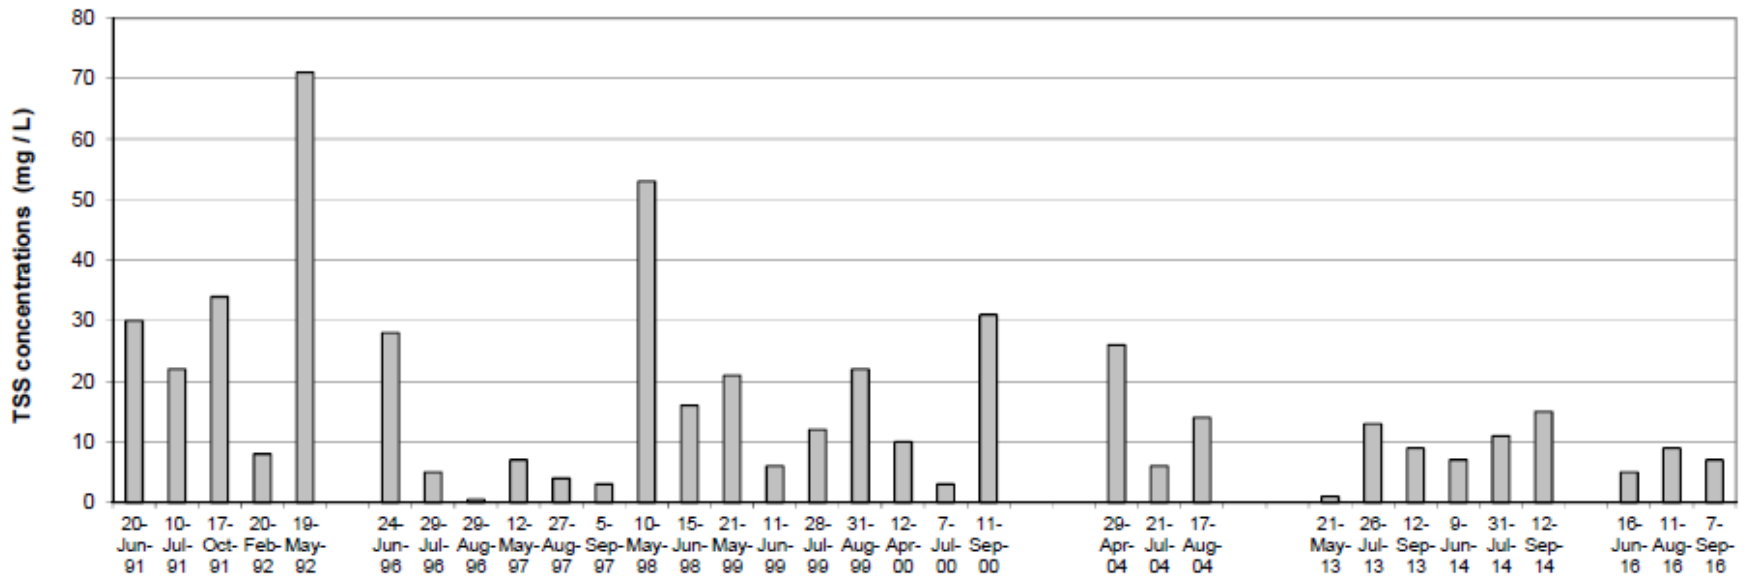
Long-Term TSS in Lake Luxembourg

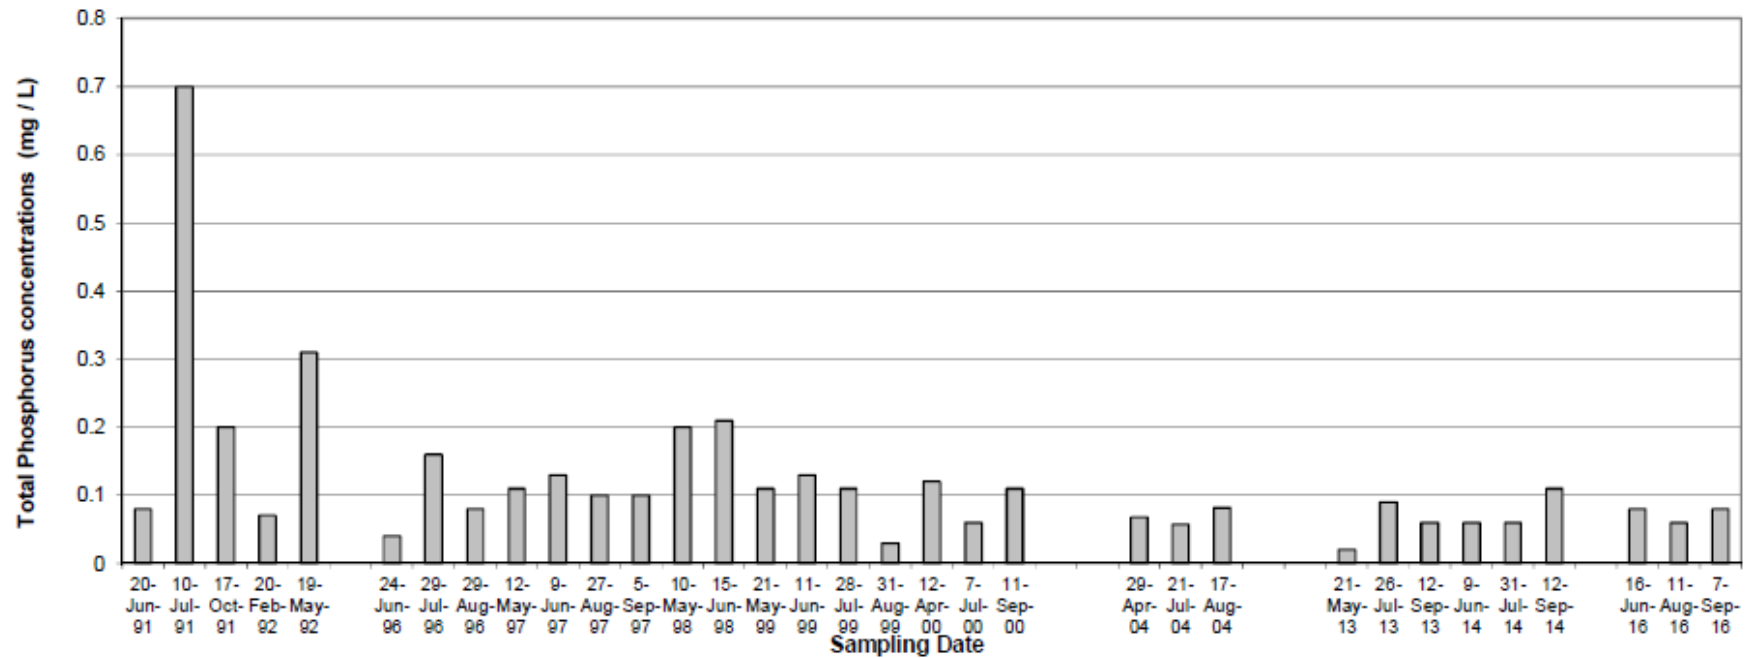
Long-Term TP in Lake Luxembourg

- ✱ 0.05 mg/L; mean surface water TP concentration (TSI for TP of 62)
- ✱ 2013 mean 0.06 mg/L (TSI for TP of 63)
- ✱ 2014 mean 0.08 mg/L (TSI for TP of 67)
- ✱ 2016 mean 0.07 mg/L (TSI for TP of 66)

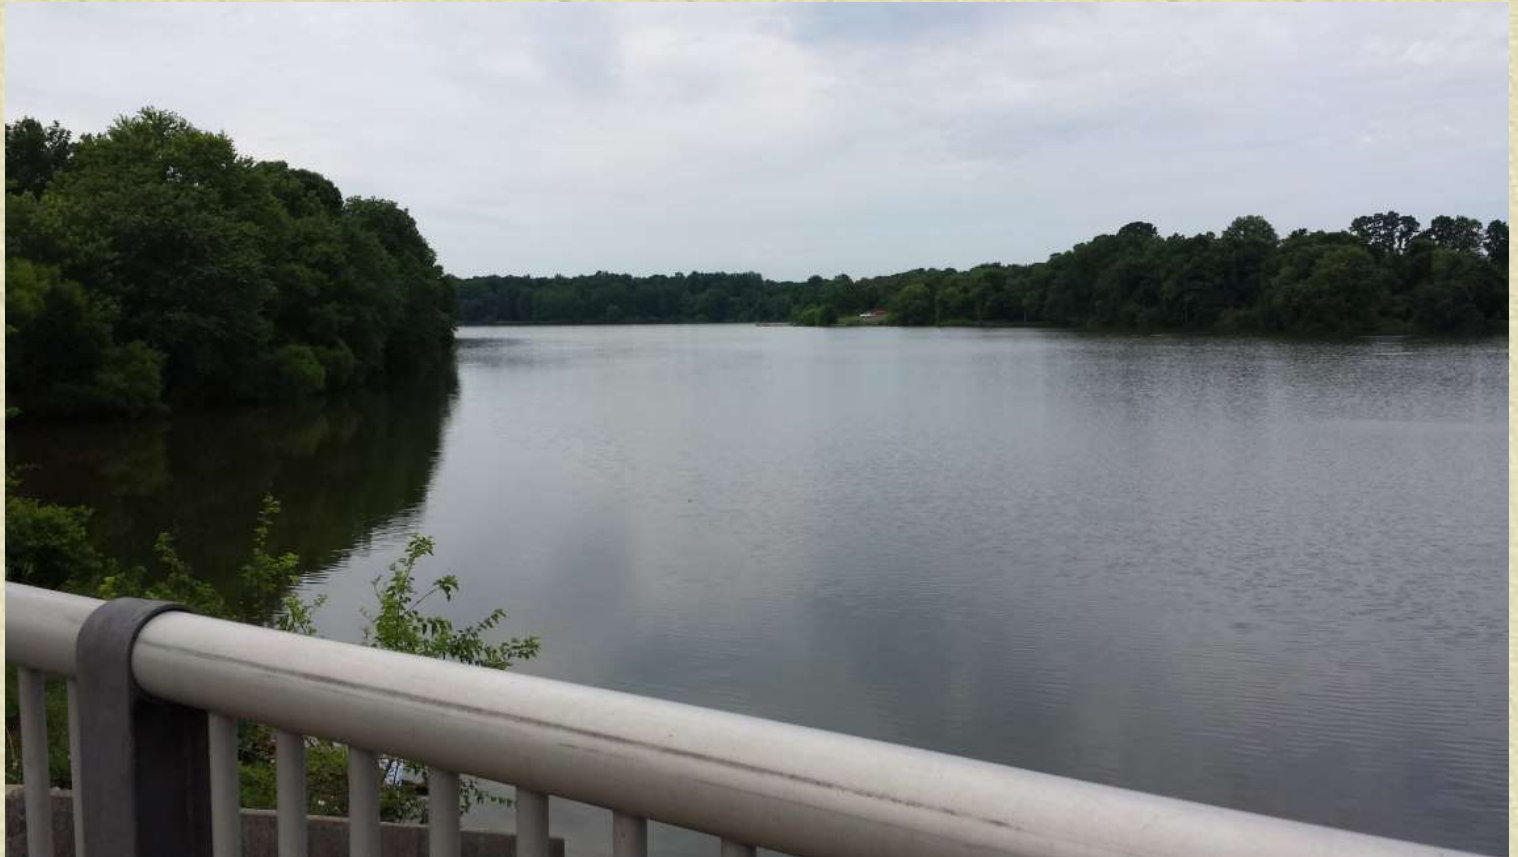
Conservation Pool

(9 July 2014; note high turbidity)

-
- ✧ Originally designed to function as a BMP.
 - ✧ Now a source of pollutants instead of a sink.
 - ✧ In order for any update BMPs or watershed management activities to have a positive impact on Lake Luxembourg, something must be done with the conservation pool.
 - ✧ Converting the conservation pool into a large-scale, regional BMP (flood plain / wetland BMP) would produce the single largest reductions of TP and TSS of any implemented BMP
