Legacy Sediment - The “Dirt on Conventional Buffers” and Results From the Big Spring Run Restoration and Monitoring Project

Pennsylvania Legacy Sediment Workgroup

Big Spring Run (BSR) Aquatic Ecosystem Restoration and Monitoring Project

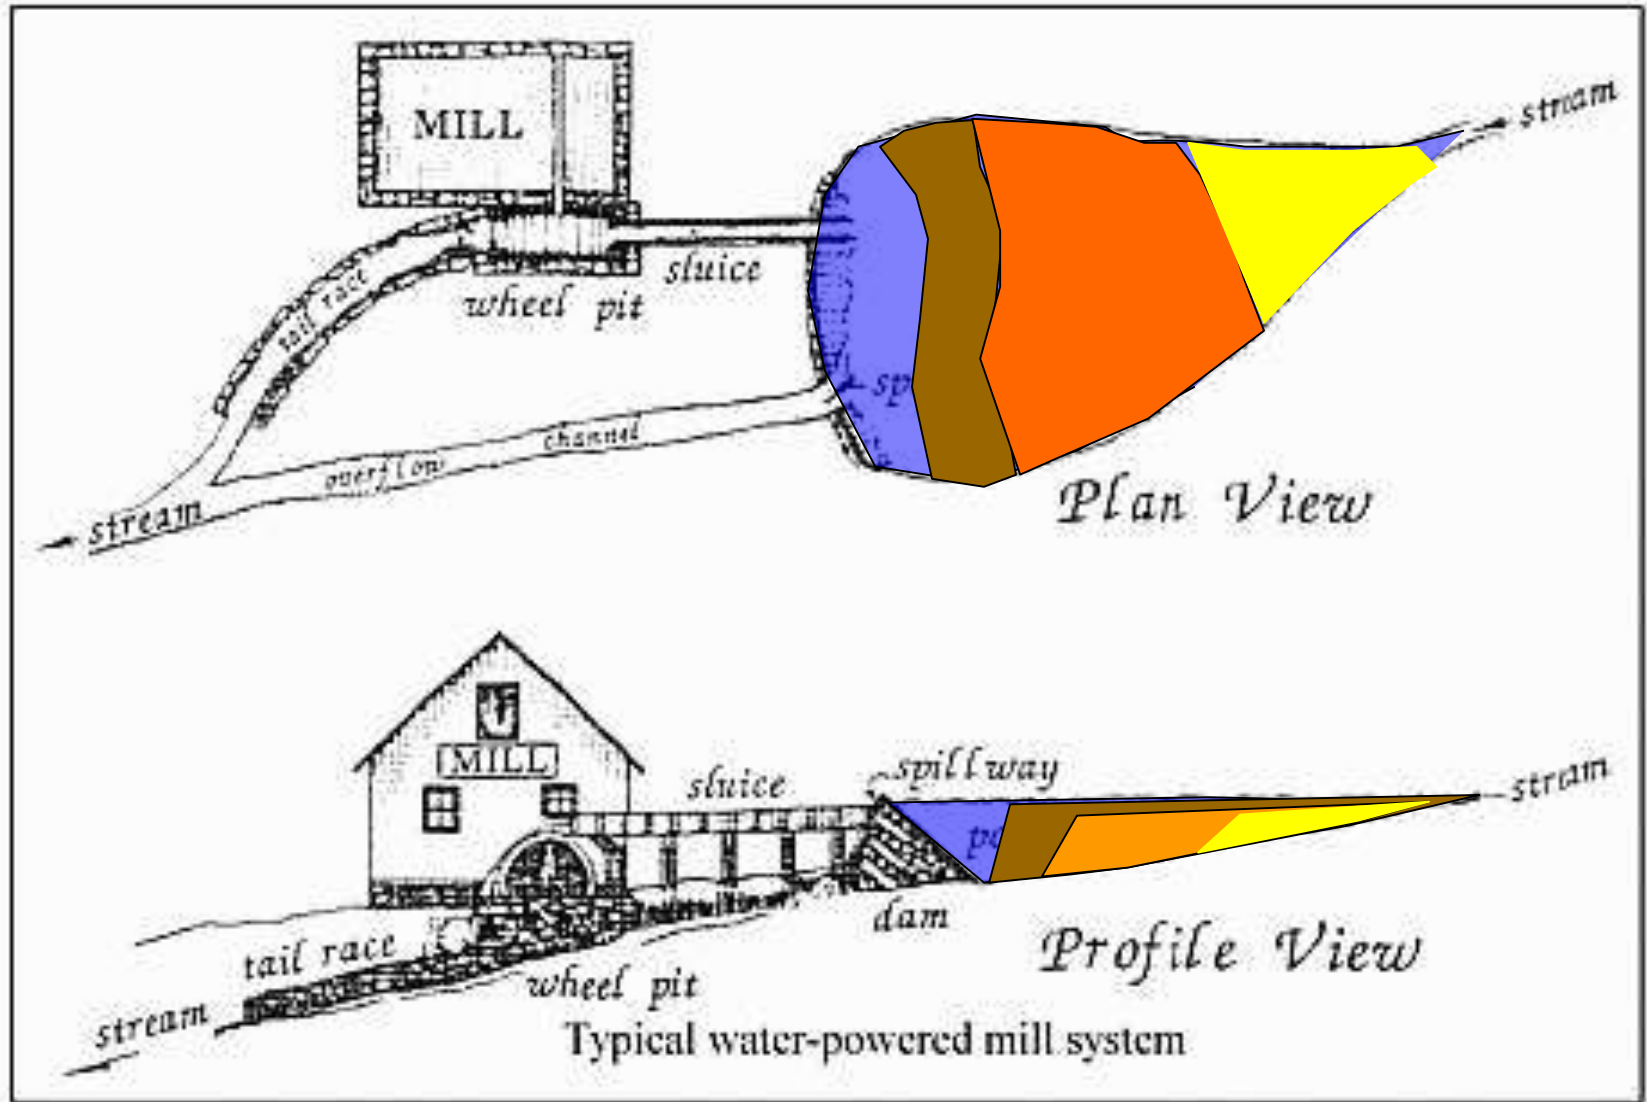
Impact of Water-Powered Mills on Sediment Storage

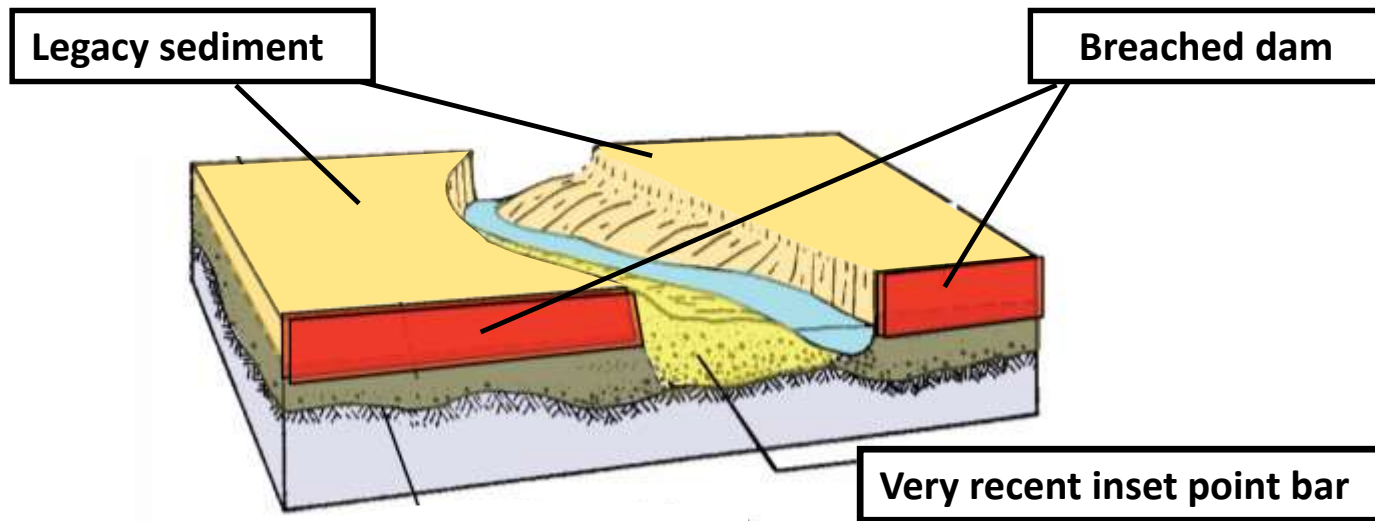
Valley base level controls matter!

Modified from Jacobson and Coleman, 1986 after Walter and Merritts, 2008

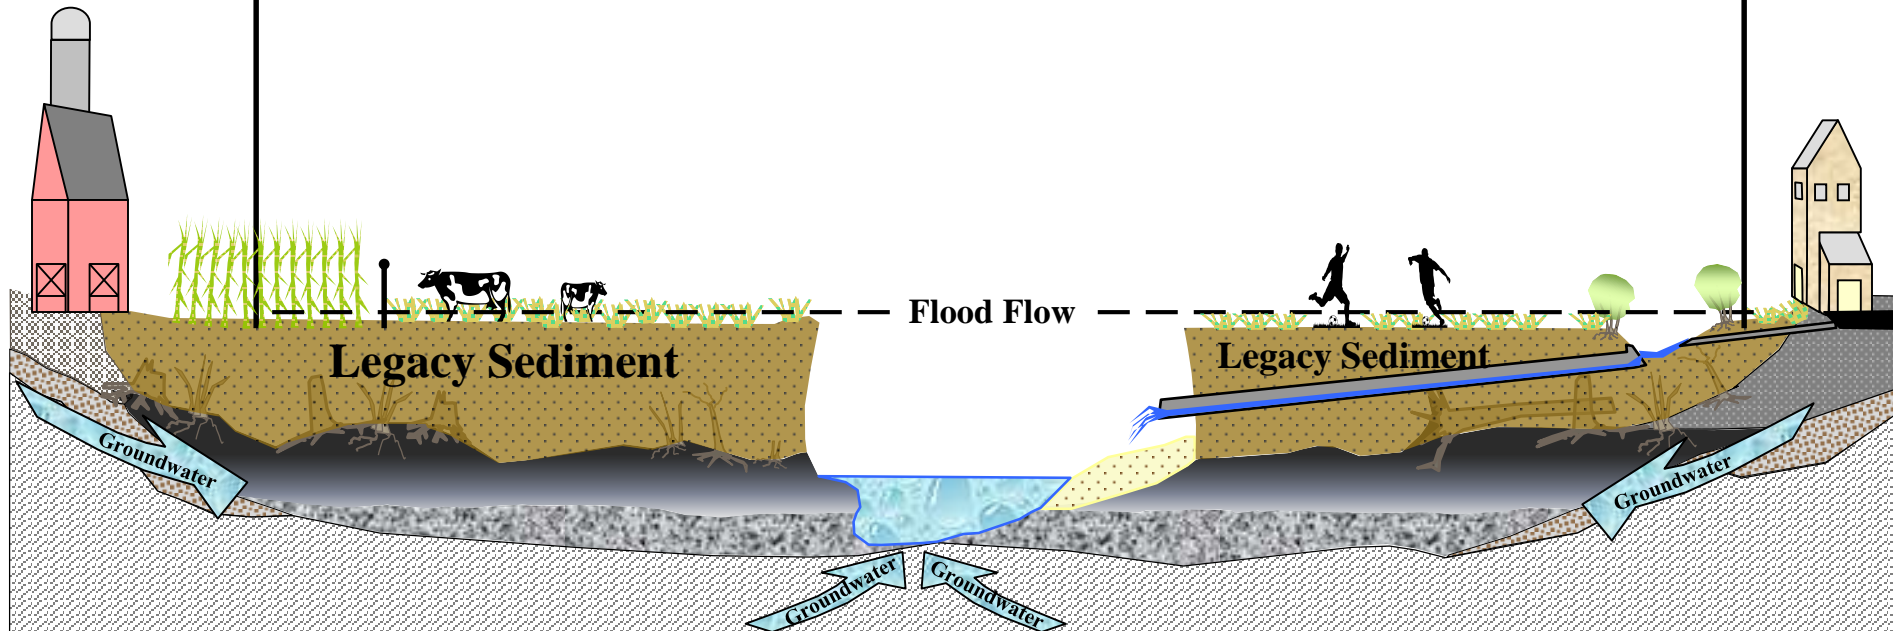
Conventional wisdom

Typical Reservoir and Valley Cross Section

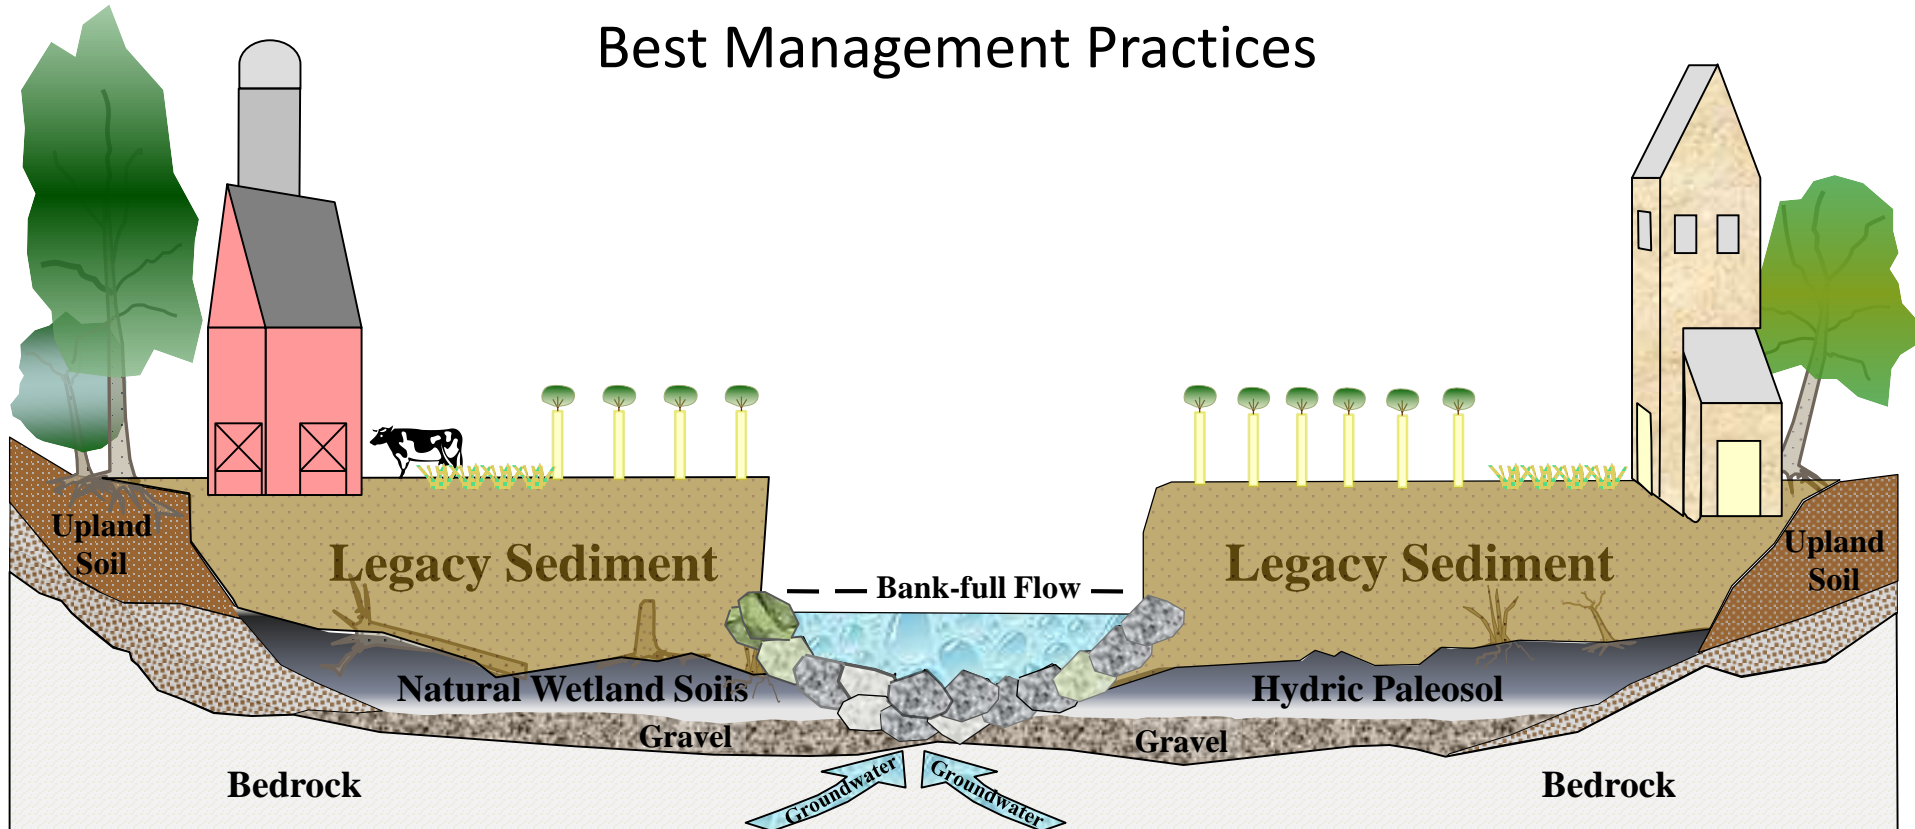
Conventional wisdom

Big Spring Run - Type Section

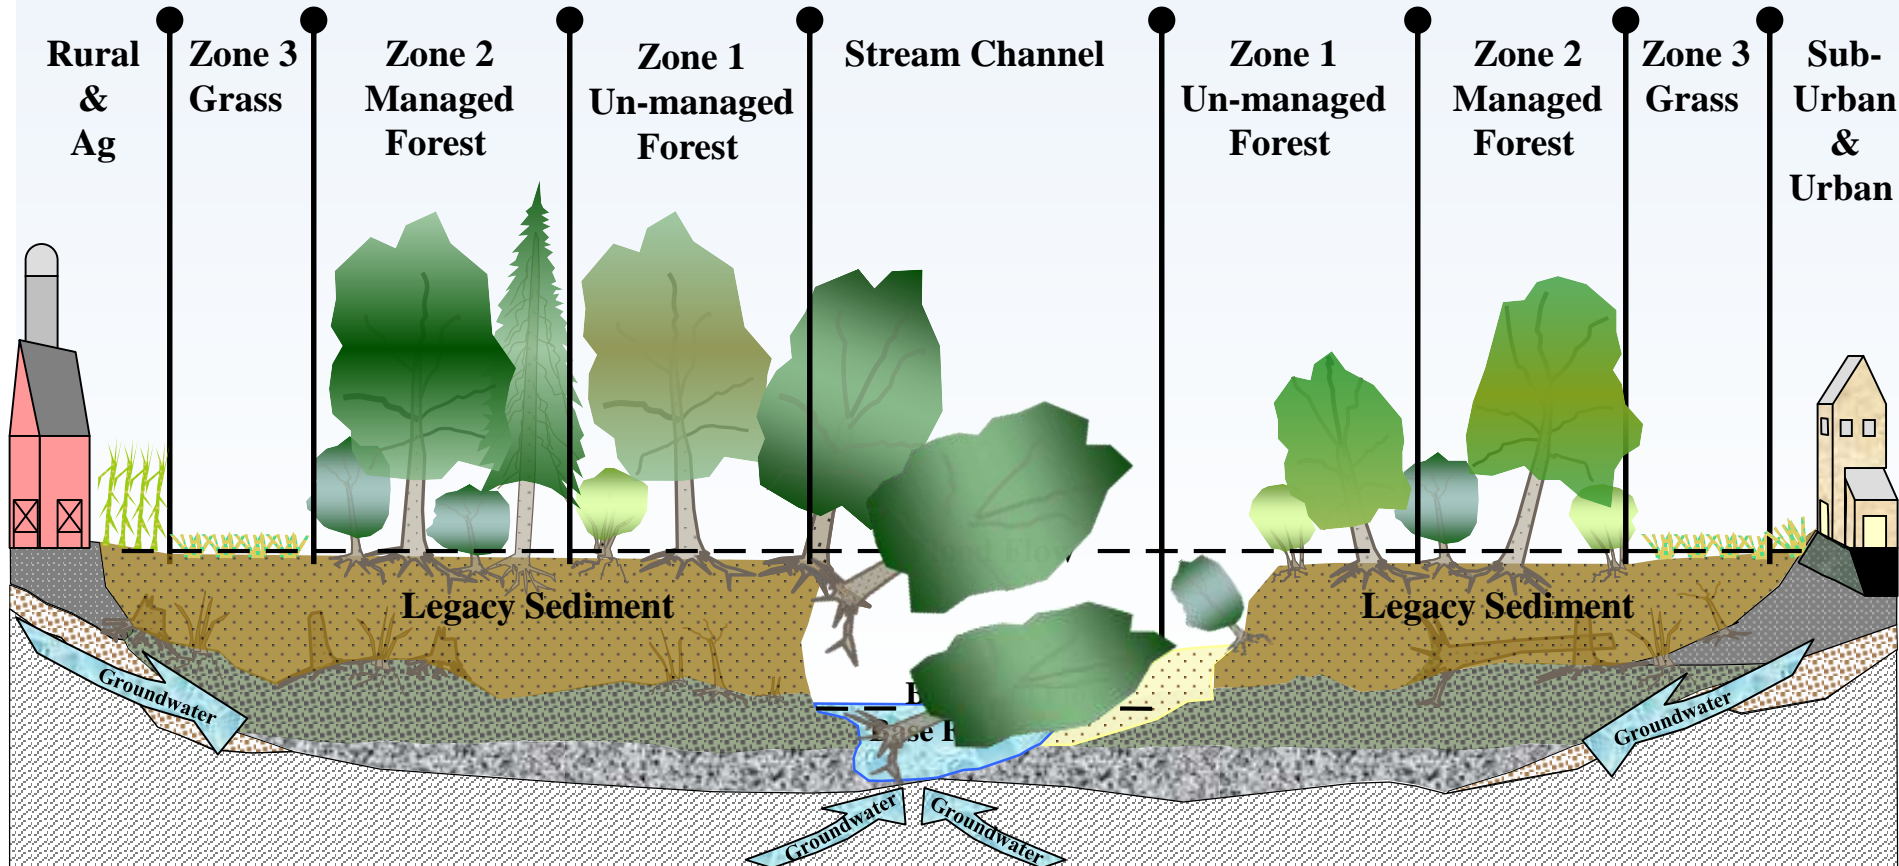
Riparian Forest Buffers - “Three-zone Concepts”

University of Maryland, Maryland Cooperative Extension, 1998.

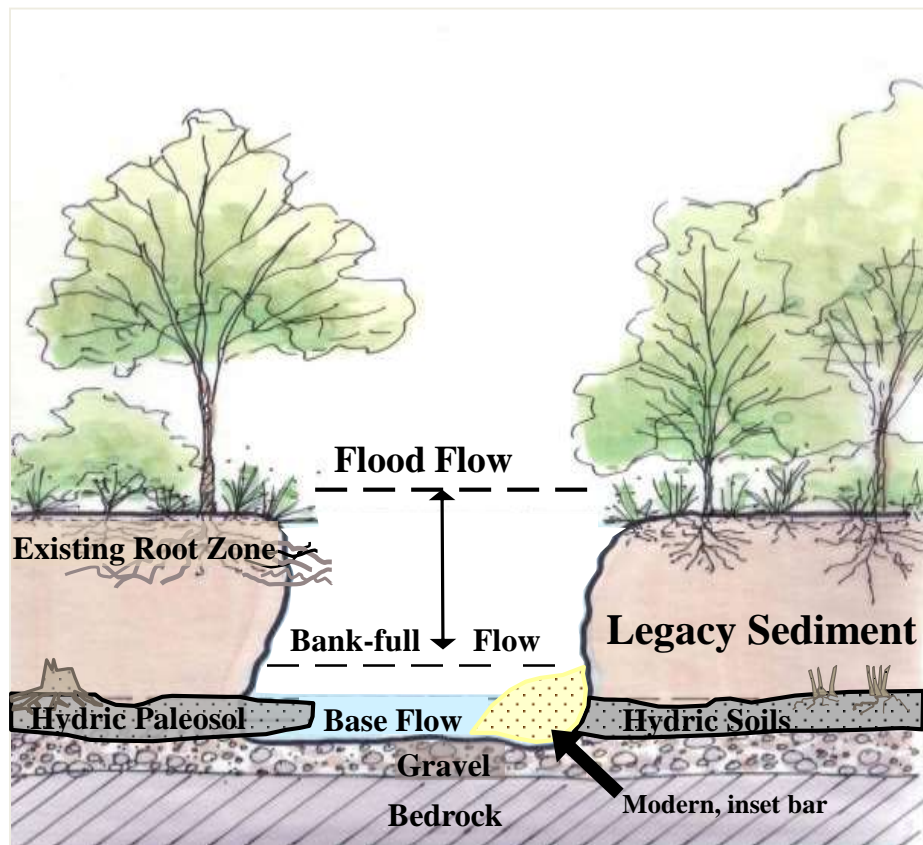
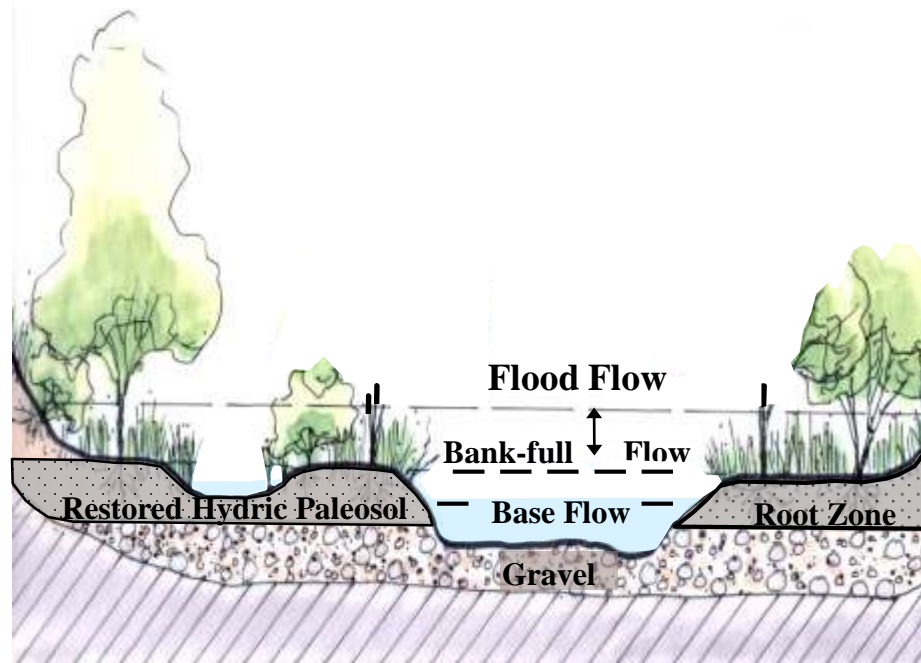
Natural Floodplain, Stream and Riparian Wetland Restoration Best Management Practice

Conceptual Design

Typical Existing Conditions ➡ Proposed Restoration

➡ Natural Valley Morphology
