Identifying Goals and Objectives for Watershed Restoration Projects

Justin Kauffman

-Turnkey Environmental Solutions

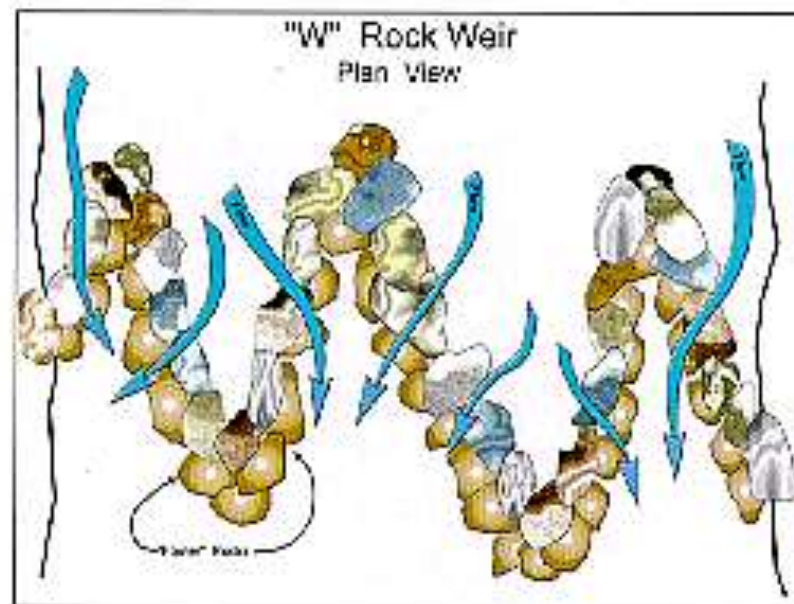
FIGURE 8-26. "W" rock weir. [Rosgen, 1993a]
